TITLE: Seats second row, outer seats, noise

REF NO:	ISSUING DEPARTMENT:		ARKET:
TJ 30599.3.1	Technical Service		s and Canada
3 US 7	PARTNER:	ISSUE DATE:	STATUS DATE:
	7510 Volvo Car USA	2016-11-22	2016-11-30
FUNC GROUP: 8530	FUNC DESC: Rear seat, passenger seat, bench	Page ⁻	1 of 12

Technical Journal 30599.3.1

VOLVO	Volvo Car Customer Service	TJ	30599
Title	Rear seat, second row	Page	1 (10)
Action	Product fix	Operation number:	98641-2

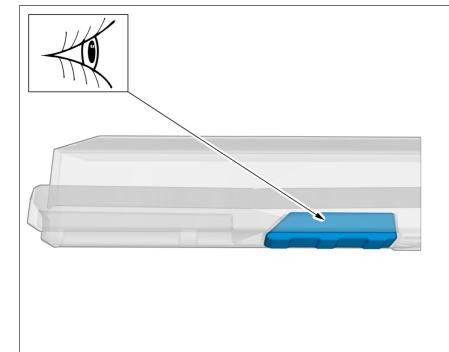
Caution! Make sure that the component is positioned correctly.

On both sides.
