Technical Journal

“BLIS service required” message in DIM without DTCREF NO:
TJ 25252.7.0ISSUING DEPARTMENT:
Technical ServiceCAR MARKET:
United States and CanadaPARTNER:
3 US 7510 Volvo Car USAISSUE DATE:
2016-11-30STATUS DATE:
2016-12-02FUNC GROUP:
3872FUNC DESC:
Collision avoidance**Page 1 of 6****“Right first time in Time”**

Volvo Car Customer Service		
	TJ Instruction	
	TJ No 25252	
		Date November 2012 Issue 01
Title	"BLIS service required" message in DIM without DTC

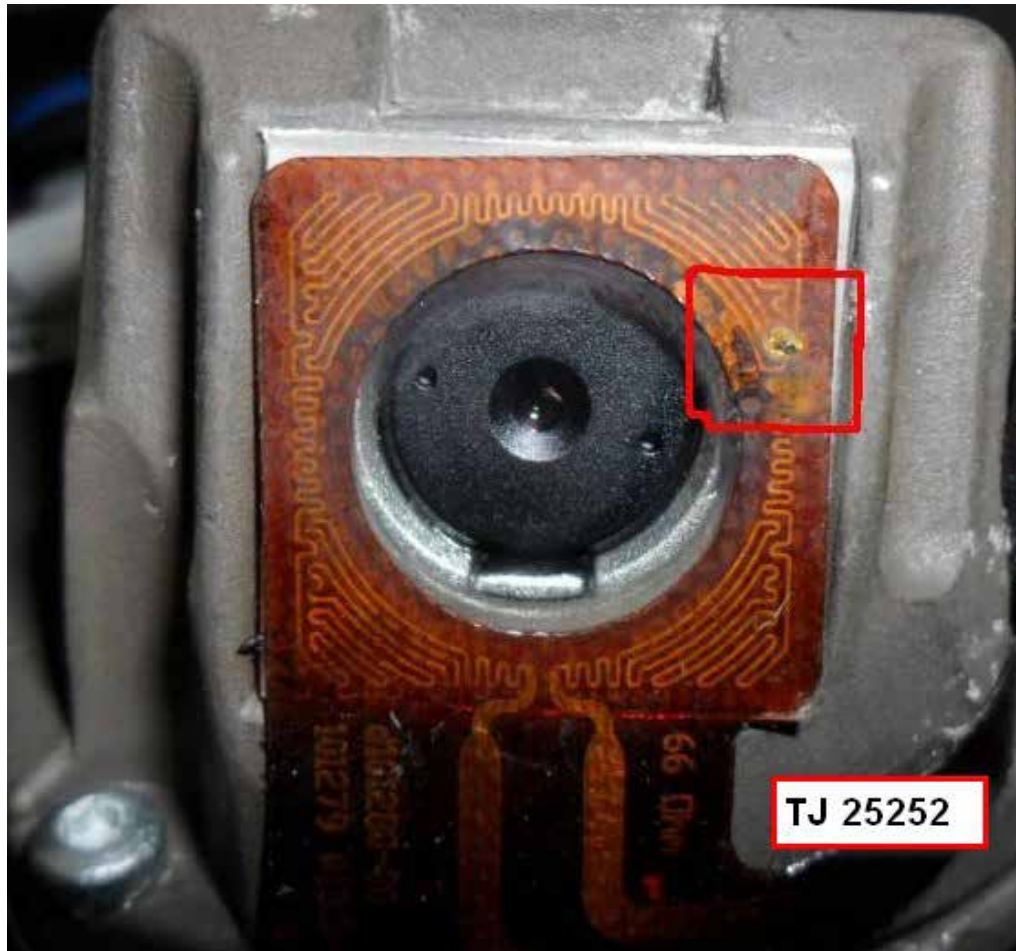
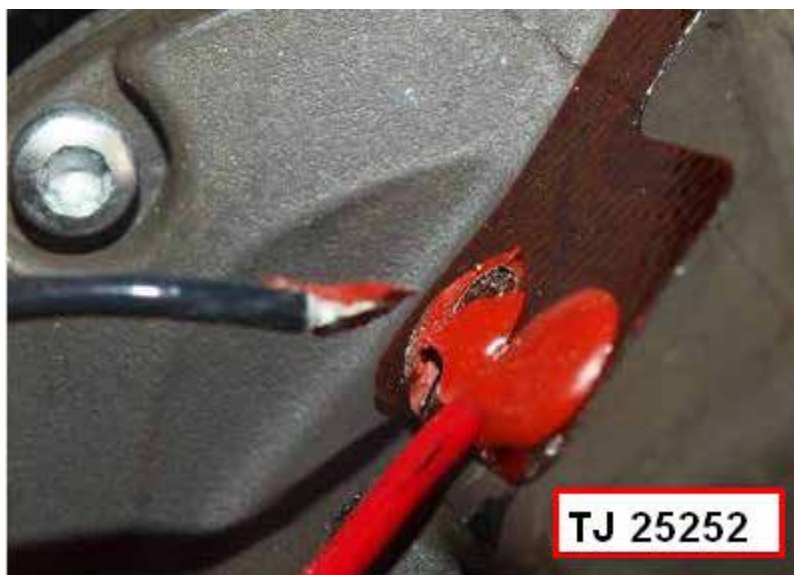
This may occur if the BLIS camera heating element is broken due to a hot spot, or if the lead cable for the heater element has become loose due to a bad soldering.

* If there is a visible hot-spot on the heater element, or a loose lead cable, replace the heating element according to VIDA instructions.

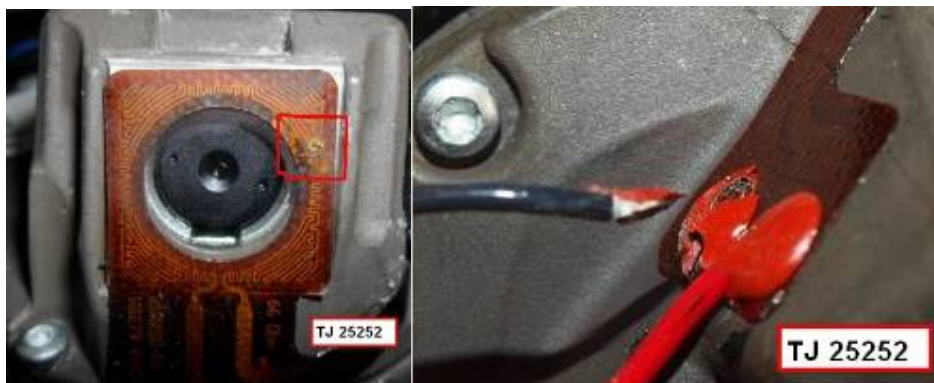
Hot spot

Broken connection

Examples of possible faults to the heater grid.
