**XC90 T8, Charge & Hold functions not available**REF NO:  
**TJ 31849.2.0**ISSUING DEPARTMENT:  
**Technical Service**CAR MARKET:  
**United States and Canada**PARTNER:  
**3 US 7510 Volvo Car USA**ISSUE DATE:  
**2016-11-28**STATUS DATE:  
**2016-12-01**FUNC GROUP:  
**3113**FUNC DESC:  
**Battery, high voltage**

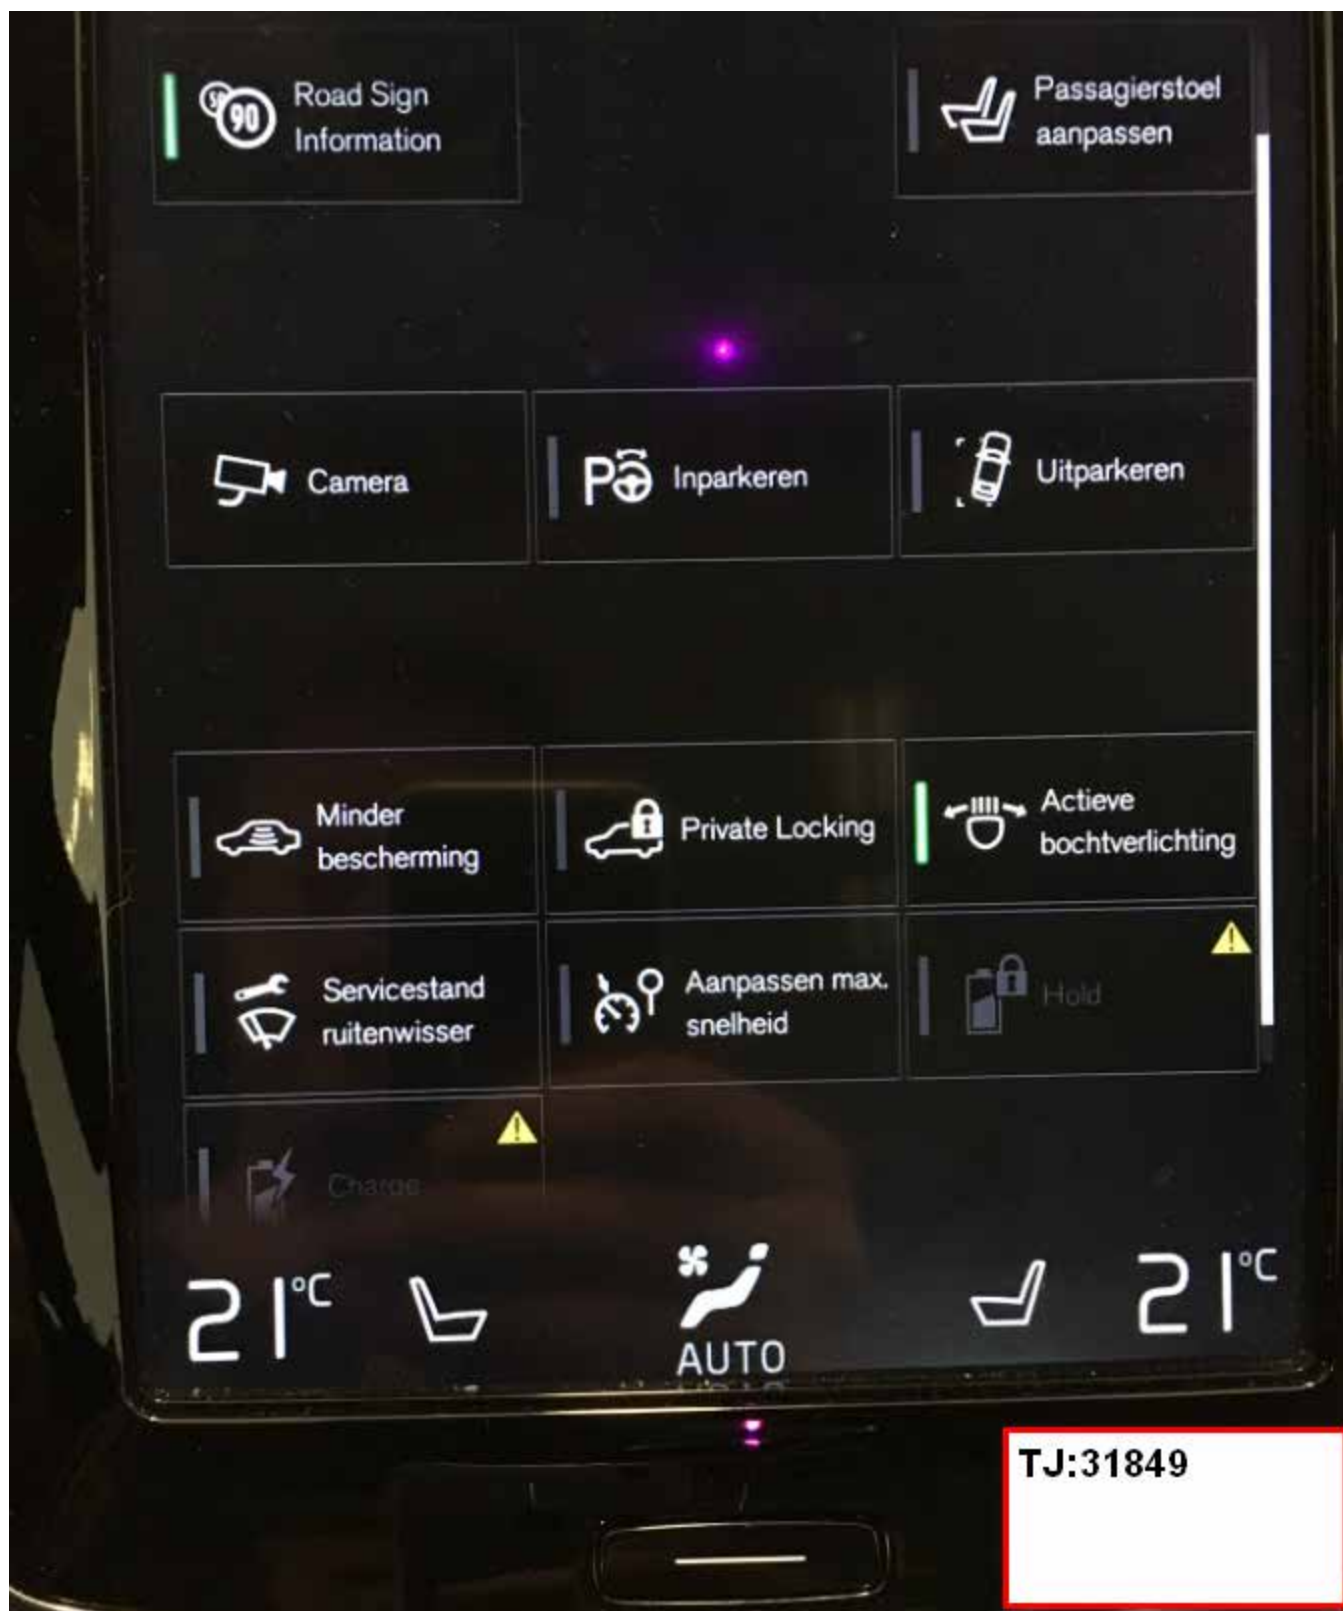
The driver may experience that Charge and Hold functions are not available and the icons have a yellow triangle and are grayed out.

Perform total upgrade according to TJ 31543.
