EA39

Under bonnet trim - engine cover (SC16/01)

Transaction No.: 2041887/2

Release date: Feb 4, 2016

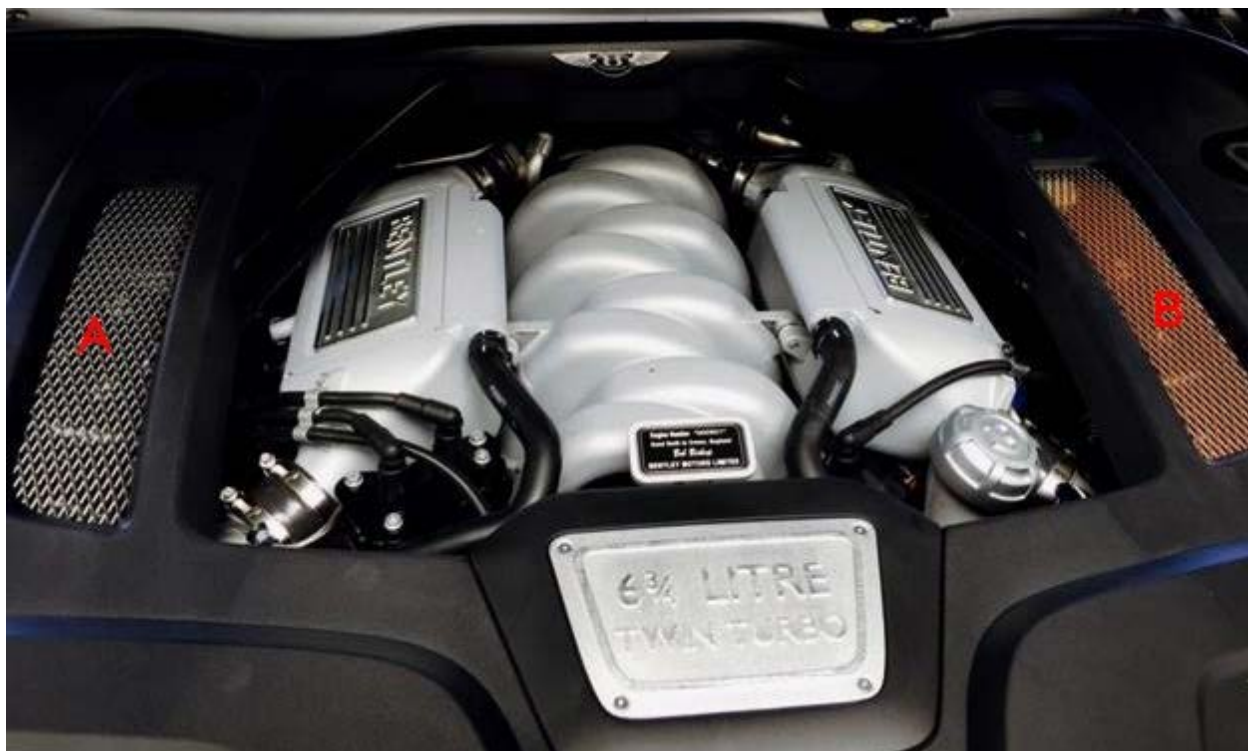
Figure 1

A number of under bonnet trim parts, engine covers, may have been assembled using incorrect material. The suspect material is mild steel mesh and may be prone to oxidation

The metallic grills A and B need to be checked using a magnet, if either grill is found to be magnetic then replace the engine cover assembly (see Figure 1)
