New replacement software for the engine control modules and the transmission control module has been created to address customer satisfaction issues concerning driveability.

The software update within this campaign has been devised to ensure all W12 engine derivative vehicles within the specified VIN range have the latest level of software installed within the engine control modules and the transmission control module.

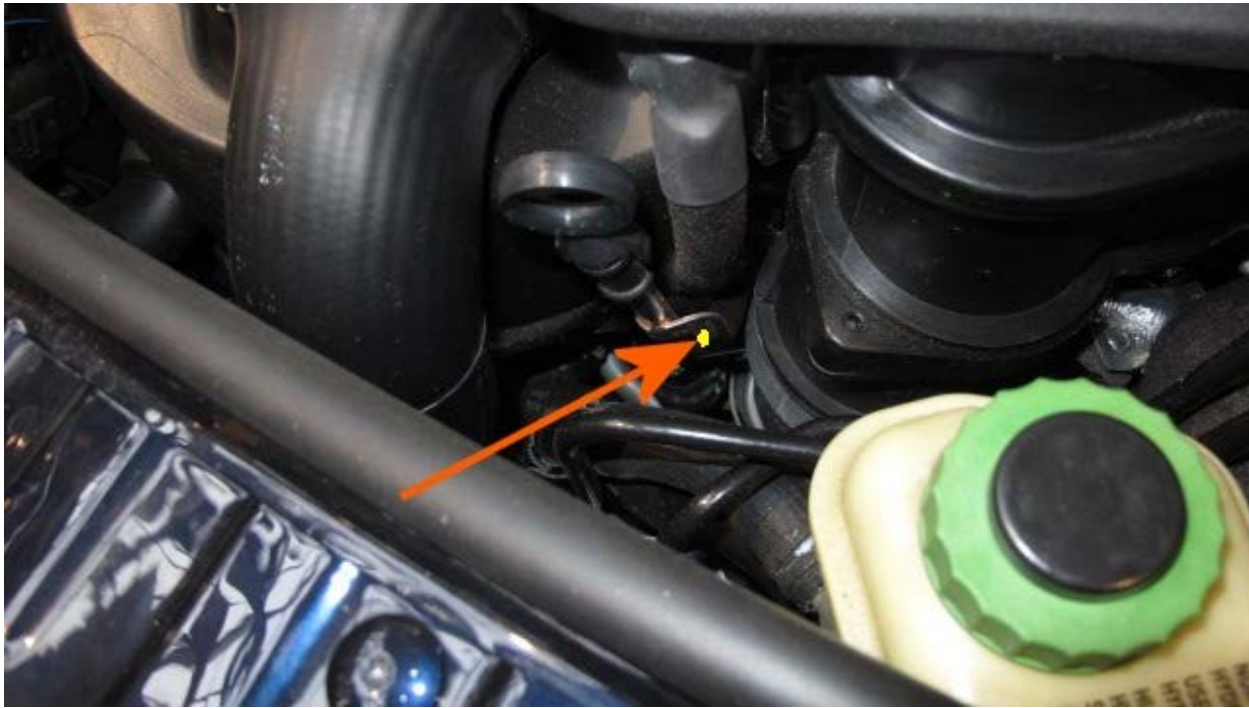
Figure 11

Yellow paint mark on the engine oil dipstick tube bracket (Figure 11)

4. Place a Yellow confirmation mark on the rear of the engine oil dipstick tube bracket (Figure 11)
