## Technical product information

<b>Topic</b>	Mulsanne Steering Gear - Hydraulic Oil leak
<b>Market area</b>	Bentley: worldwide (2WBE),Hongkong-Macau (5HK)
<b>Brand</b>	Bentley
<b>Transaction No.</b>	2043019/1
<b>Level</b>	EH
<b>Status</b>	Approval
<b>Release date</b>

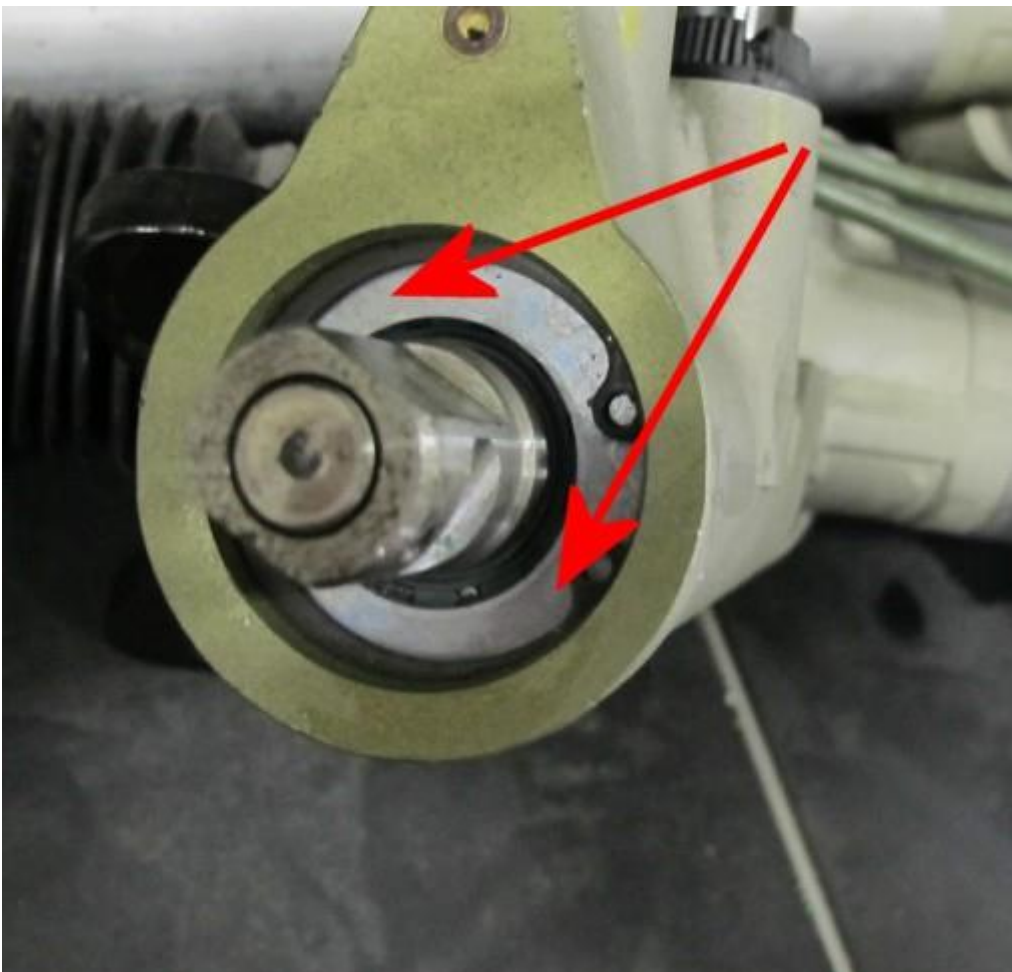
Figure 1.

Hydraulic fluid leak from the Steering Rack Pinion Bearing.

The Steering Rack may leak low pressure hydraulic fluid from the Pinion Bearing due to degradation of the Pinion Bearing oil seal.

**NOTE** – This Technical Product Information document is only relevant to leaks from the Pinion Bearing seal – *figure 1*. If the leak is from the Torsion bar - *figure 2* - the Steering Rack Assembly must be replaced. If it is not possible to positively identify the source of the hydraulic fluid leak, the Steering Rack Assembly should be replaced.

**Vehicles with a first time failure, over 10.000 miles or 16.000 kilometres** - replace the Pinion Bearing oil seal.

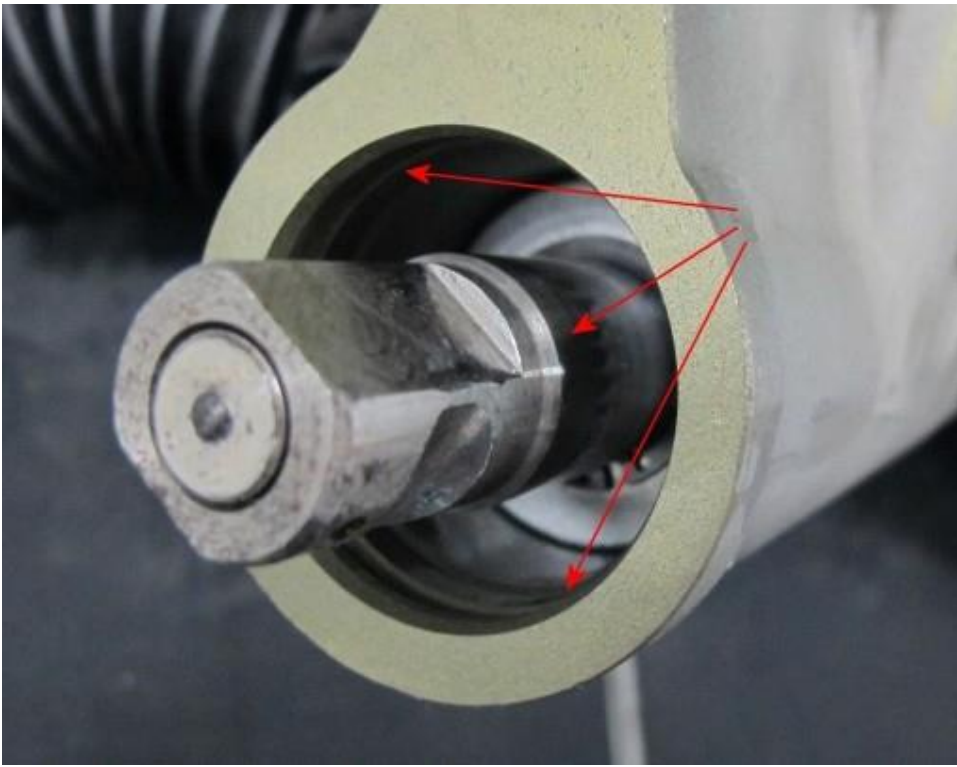
Figure 7.

Carefully inspect the Pinion Shaft and Housing for damage or corrosion, remove any residual debris. If either the pinion shaft or housing has damage or corrosion in the area where the hydraulic oil seals locate, the Steering Rack assembly should be replaced – *figure 7.*
