ARTICLE: T-16-09-01

## SUBJECT: SLINGSHOT – Angle Drive Pinion Seal Service

### MODELS: 2015-2016 SLINGSHOT MODELS

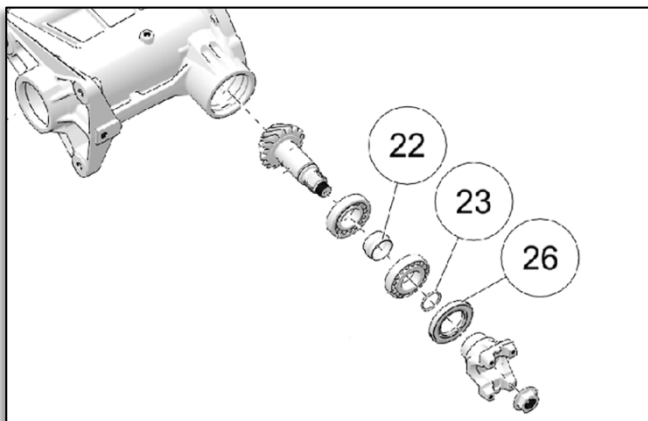
**IMPORTANT:** The following items must be replaced when performing this procedure.

(Item 22) **5138157 – Crush Sleeve**

(Item 23) **3610207 – O-Ring**

(Item 26) **3235641 – Yoke Seal**
