# TECHNICAL SERVICE BULLETIN

Bulletin Number: V-16-01A-C  
Model Years: 2015-2016

## SUBJECT: Victory International Cruiser—Exhaust Emissions

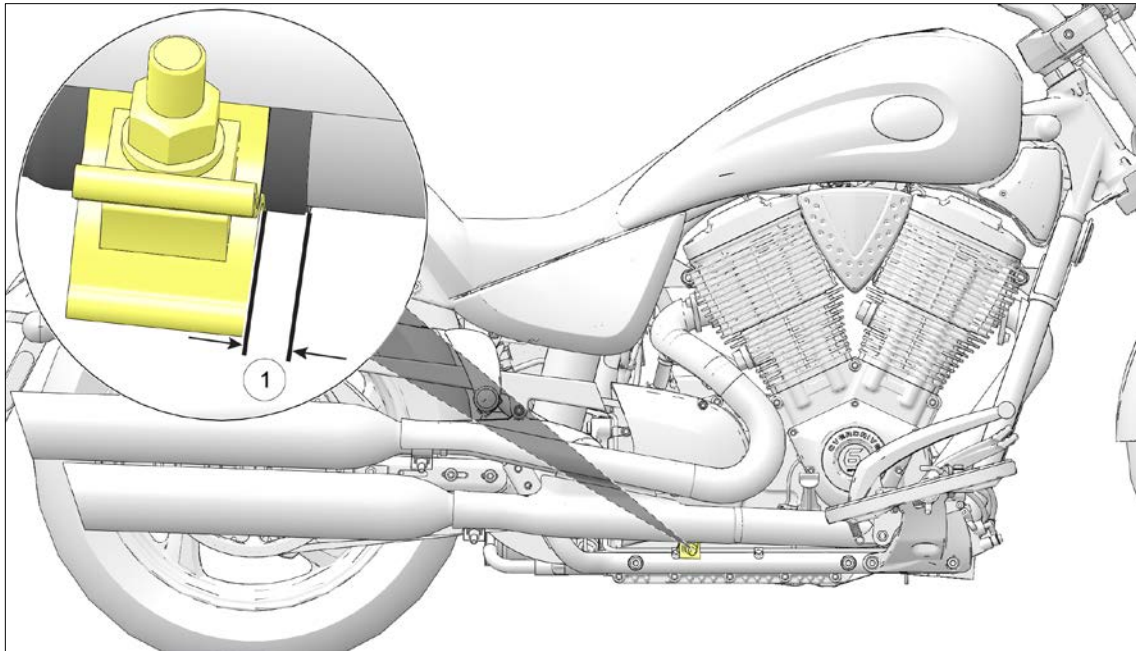
1. Locate the exhaust clamp between the mid pipe and the header pipe, shown below.
2. Inspect the placement of the clamp.

Clamp should be located at the front edge of the slotted mid pipe or up to 6mm (1/4 inch) depth ① toward the rear of the motorcycle. The clamp should never be located forward of the front edge of the slotted mid pipe.

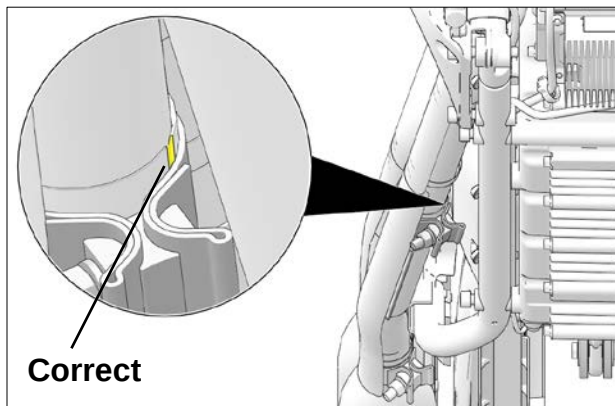
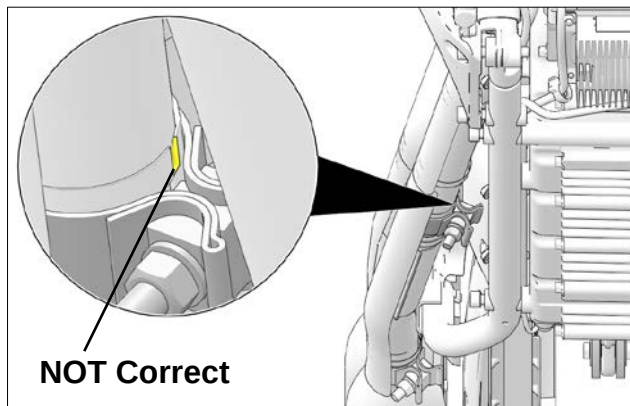
3. Inspect the rotation of the clamp.

Open section of clamp should not line up with slot in mid pipe and be at least 45° away from the slot on either side. Band of the clamp should cover slotted sections of the mid pipe.

### If clamp placement and rotation are **CORRECT**

File a warranty claim for V-16-01B. No further action is required.

### If clamp placement and rotation are **NOT CORRECT**

Proceed to EXHAUST HEADER PIPE INSPECTION AND CLAMP REPLACEMENT procedure.

**IMPORTANT:** Clamp should not be reused after removal. Loosening and repositioning of clamp is not recommended and may result in a vehicle that does not meet emissions requirements.

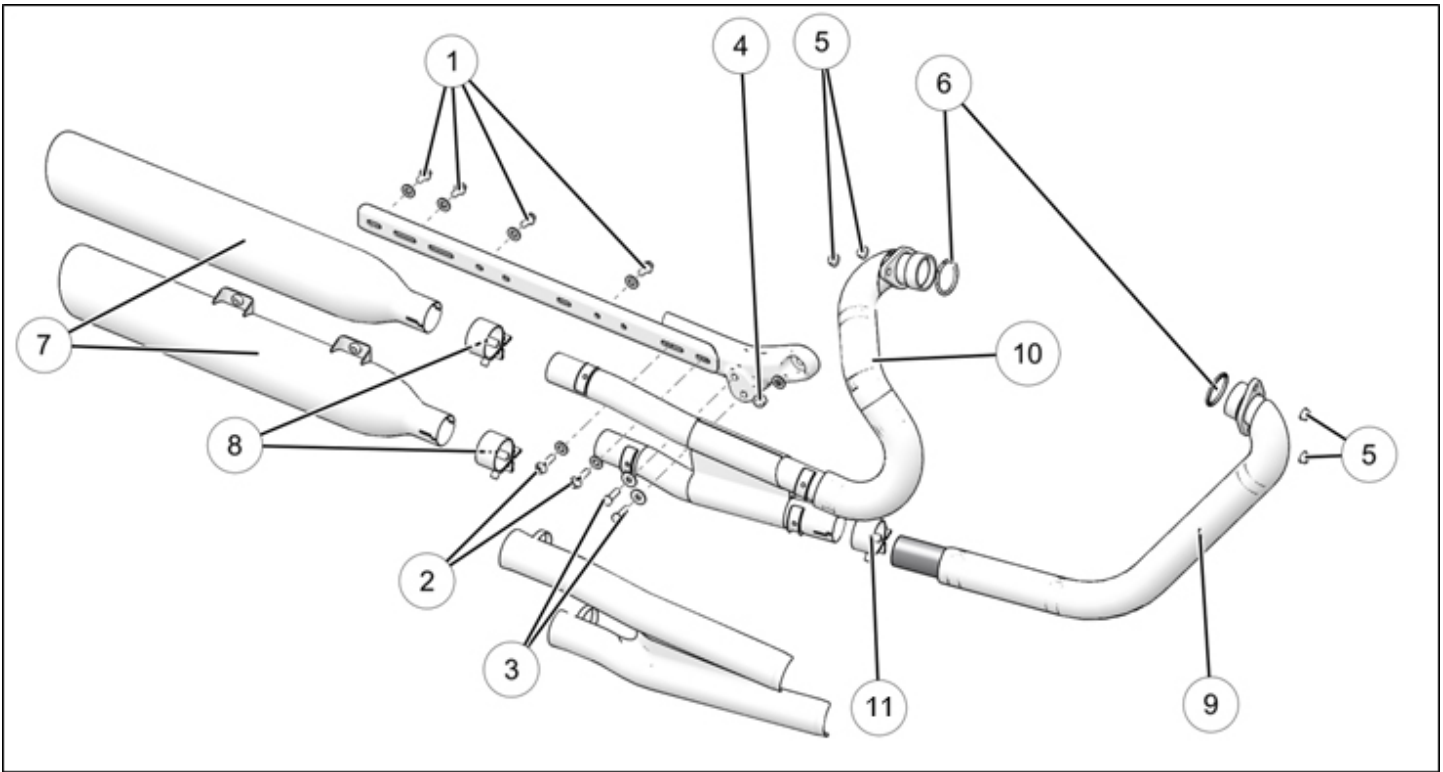
2. Loosen upper muffer clamp (8).
3. Remove two upper muffer bolts (1).
4. Slide upper muffer (7) back to remove, discard clamp.
5. Loosen lower muffer clamp (8).

6. Remove two lower muffer bolts (1).
7. Slide lower muffer (7) back to remove, discard clamp.
8. Loosen the clamp (11) between the front (9) and rear (10) header pipes.

9. Remove flange nuts (5) from front and rear header pipe.
10. Remove rear header, discard clamp.
11. Remove and discard front and rear exhaust port gaskets (6).

12. Inspect rear header pipe slotted joint surface where it meets front header pipe. Pipe surface should be smooth and straight, free of any bending or deformation.

**If NO bending or deformation is observed** – Continue to the installation process below to reassemble the exhaust system using the existing rear header pipe and new exhaust clamps. File a warranty claim for V-16-01C.

**If bending or deformation is observed** – Submit a request for rear header pipe replacement through normal warranty channels. Continue to the installation process below to reassemble the exhaust system using the replacement rear header pipe and new exhaust clamps. File a warranty claim for V-16-01C.

1. Install new exhaust gaskets ⑥ into front and rear cylinder exhaust ports.
2. Install rear header pipe ⑩ with new clamp ⑪.
3. Install and hand tighten front and rear cylinder flange nuts ⑤.
4. Install lower muffler ⑦, new clamp ⑧ and hand tighten lower muffler bolts ①.
5. Install upper muffler ⑦, new clamp ⑧ and hand tighten upper muffler bolts ①.
6. Torque front and rear cylinder flange nuts ⑤ to 16 Nm (12 ft-lbs).
7. Torque lower and upper muffler bolts ① to 24 Nm (18 ft-lbs).
8. Adjust placement and rotation of new clamp ⑪ according to EXHAUST SYSTEM INSPECTION PROCEDURE above and torque to 42 Nm (31 ft-lbs).
9. Adjust placement and rotation of new clamps ⑧ according to EXHAUST SYSTEM INSPECTION PROCEDURE above and torque to 42 Nm (31 ft-lbs).
