## SUBJECT: 2017 Victory Octane Motorcycles – Speedometer Needle Sticking

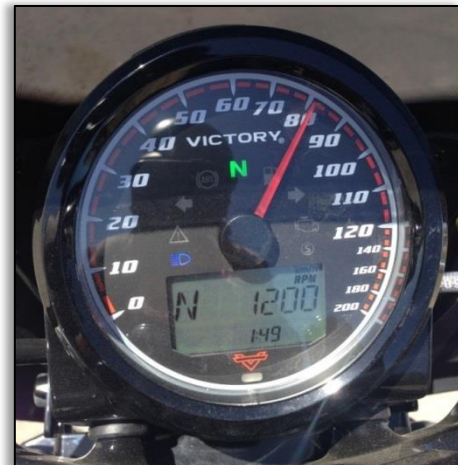
Victory engineering has determined that some early Octane speedometers were manufactured using insufficient adhesive under the dial face. As the dial face becomes warm in ambient sunlight, the adhesive may release causing the dial face to rise and contact the needle. Riders may notice the speedometer needle hang up during operation and not return to zero.

1. Access the ODOMETER CHANGE NOTIFICATION form located under 'News, Forms & Links' on the dealer website, or by clicking [HERE](#) if viewing electronically.
2. Print two copies of the ODOMETER CHANGE NOTIFICATION. Return one copy with the affected speedometer and provide the second copy to the customer for their records.
3. Replace the affected speedometer (PN:3280664) as outlined in the 2017 Victory Octane Service Manual (PN:9926924)
4. File a WG or ST warranty claim per the WARRANTY CLAIM PROCESSING INSTRUCTIONS below.
5. Return the affected speedometer and completed ODOMETER CHANGE NOTIFICATION form to Victory through the standard warranty return channels.
