### **TECHNICAL SERVICE BULLETIN**

**BULLETIN #:** CORE 44 AXLES

**RE:** G2 Plug Weld and Casting inspection for Oil Seepage

**PART #:** 67-2051JKF, 67-2051JKFL, 67-2052JKR, 67-2052JKRS

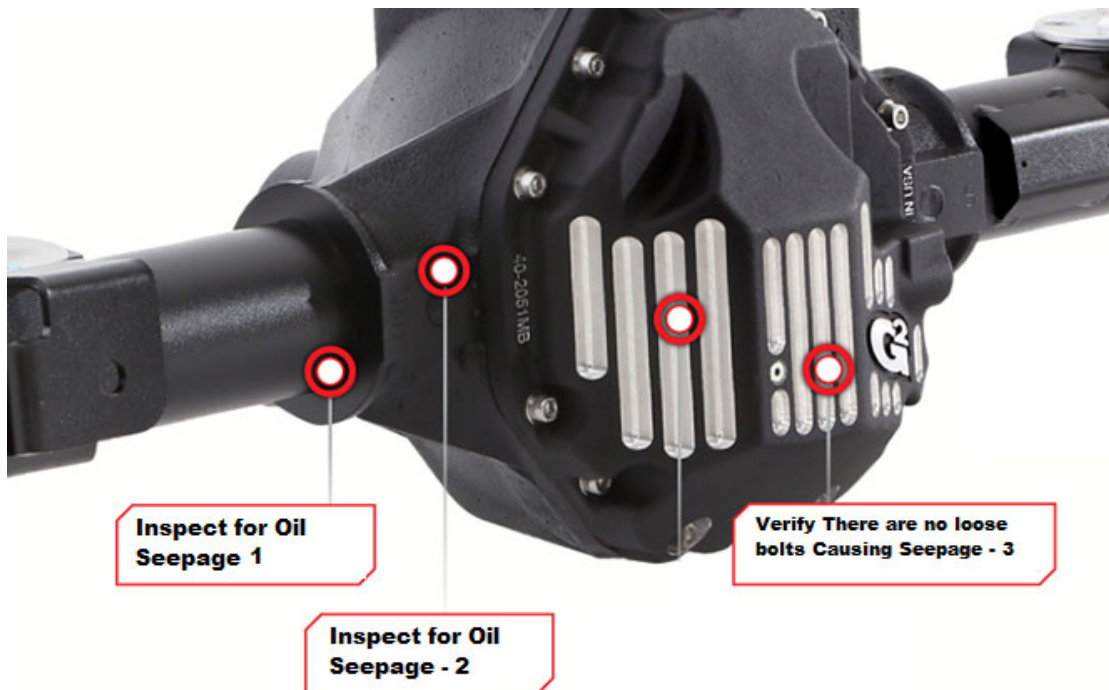
Oil Seepage has been reported from where the Tube meets the Cast Housing and Possibly the Plug Welds, Inspect the Areas labeled 1-3 below and if Oil Seepage is present refer to the Corrective Action Steps below.

Note 1 Inspect the intersection of the TUBE and CAST HOUSING, Note 2 Inspect the Plug Welds for Oil Seepage, Note 3 Verify that all Cover Bolts and Fill Holes are Tight.

If Oil Seepage is Present from the TUBE/HOUSING Intersection remove the diff cover and Apply Silicon to the TUBE and Housing intersection (See Picture 4)

If Oil Seepage is Present from the Plug Weld Contact G2 Customer Service.

If Oil Seepage is Present from the Differential Cover Tighten all loose hardware.
