# SMITTYBILT TECHNICAL UPDATE

SM-03.21.2016

APPLICATION 11-16 JK

PART NO. 76903/76904

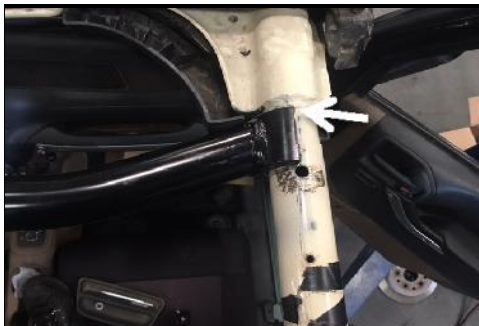
The front top cross bar should be as far forward as possible, up against the weld of the O.E. sport cage.

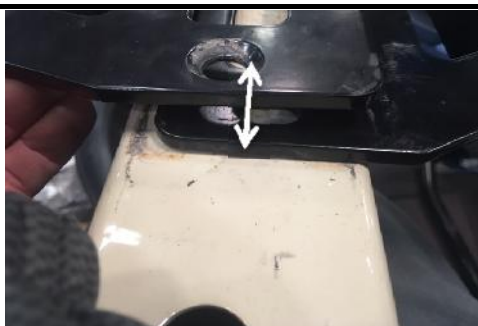
Before drilling make sure the holes of the rear and front top main plates line up correctly.

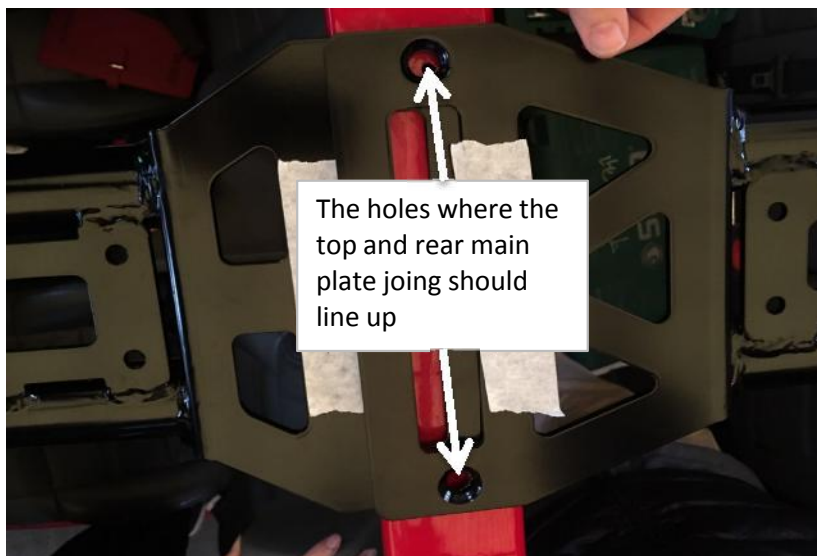
The holes where the top and rear main plate joining should line up
