## SERVICE CAMPAIGN BULLETIN

**TITLE:** Hood Latch Replacement - ROW

**DOCUMENT NUMBER:** 12 A 007

**AFFECTED VEHICLES:** McLaren P1™

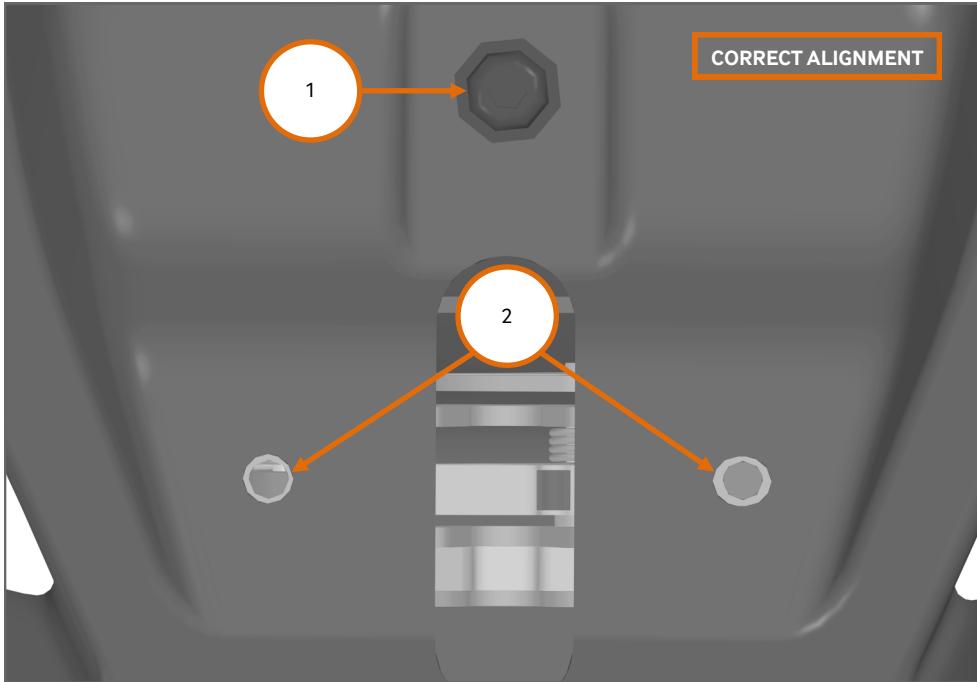
1. Please refer to BA-RM-02A052-03-001 Remove/install latch - Luggage compartment lid, to remove the hood latch.
2. Check for correct alignment of the new hood latch by fitting the top fixing bolt (1) and checking if the lower fixing points (2) of the latch are fully aligned with the holes in the front clam.
3. If the lower fixing holes (2) of the latch fully align with the clam fixing holes then proceed and install the new hood latch. Please refer to Step 8.

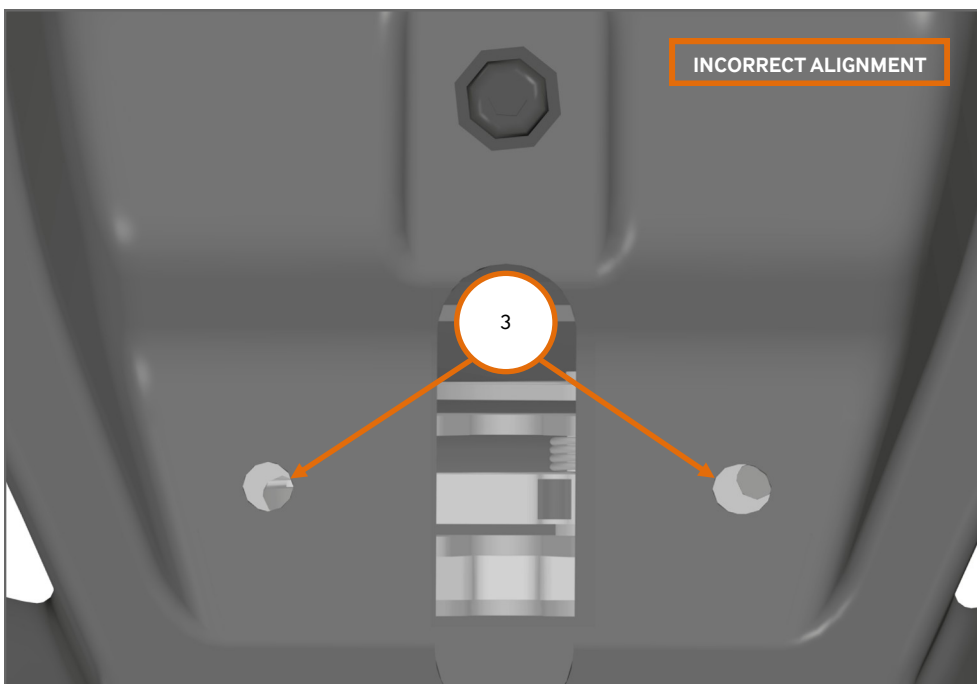
4. If the fixing holes of the latch are **not** fully aligned (3) with the clam fixing holes please refer to Step 5.

**Care Point:** Do not attempt to install the remaining two fixing bolts if the lower fixing holes are not aligned.
