SERVICE CAMPAIGN BULLETIN

TITLE:	Front Subframe Bolt Replacement
CAMPAIGN REFERENCE	044
DOCUMENT NUMBER:	11 A 065
AFFECTED VEHICLES:	Super Series
SITUATION:	Quality Engineering at McLaren Automotive require the front subframe bolts to be replaced due to the bolt 00RA534 coating being incorrect and causing degradation in the earthing circuit over time.
PROCEDURE:	This rework must be completed on all vehicles at PDI or before the handover of a new vehicle to a customer.

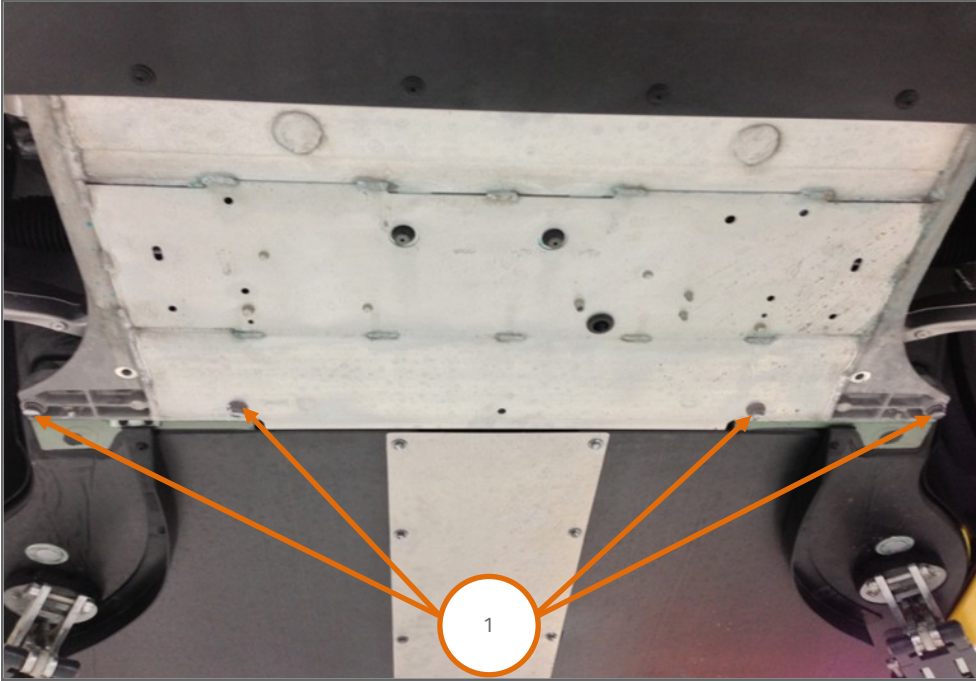
1. Please refer to CA-RM-01A001-00-001 - Secure/Lift vehicle on platform.
2. Locate the four rear mounting bolts for the front subframe (1).

3. Remove one bolt and install new bolt 11A9786CP and torque M10 x 85 to 50 Nm.
4. Repeat step 3 with the three remaining bolts.
5. Then torque all four bolts to 70Nm.
