## SERVICE CAMPAIGN BULLETIN

<b>TITLE:</b>	Vehicle Software Update to Platform 4.5
<b>CAMPAIGN REFERENCE</b>	03T
<b>DOCUMENT NUMBER:</b>	11 M 096
<b>AFFECTED VEHICLES:</b>	McLaren 675LT
<b>SITUATION:</b>	<p>Quality Engineering at McLaren Automotive have released a new software platform for the McLaren 675LT.</p> <p>The customer benefits of this software are:</p> <ul style="list-style-type: none"><li>• Improve functionality of nose lift operation</li><li>• Improve HVAC temperature control</li><li>• Improve AIS IRIS to prevent system freeze</li><li>• Introduction of Gen2 12v battery software</li></ul>
<b>PROCEDURE:</b>	<p>It is necessary to update the software on all vehicles within your Aftersales car parc, both when carrying out Pre-Delivery Inspections (PDI) and at the next service centre visit.</p>

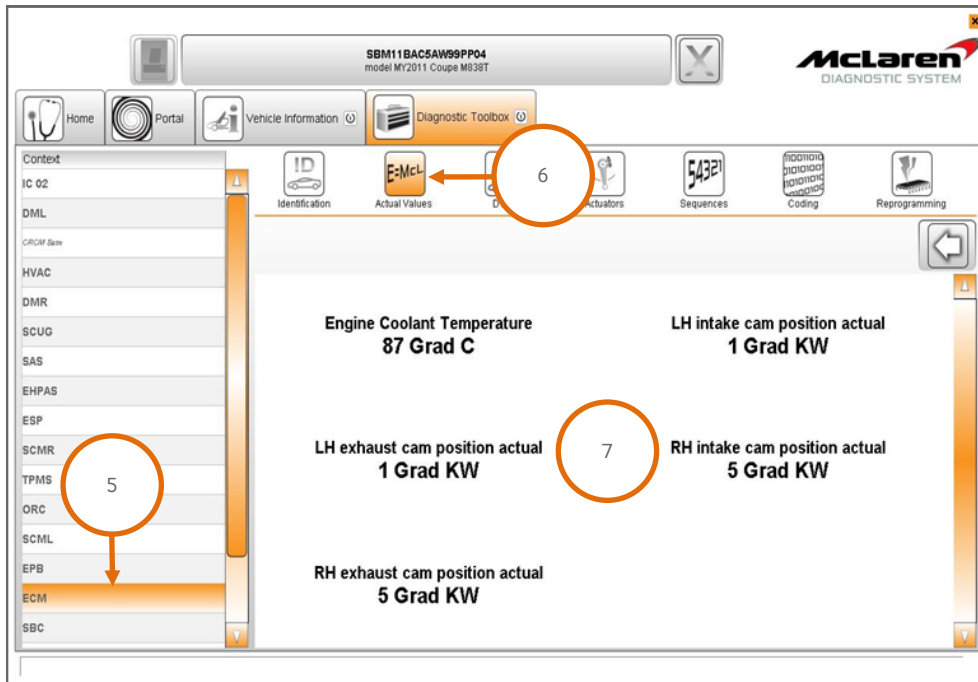
28. The inlet camshaft values should be between 9 and 12 and exhaust values should be between -9 and -12 both values will fluctuate slightly. If all values are correct no further action is required proceed to step 30. If any values are incorrect proceed to step 29 to carry out the camshaft adaption.

29. Switch the engine off, wait 30 seconds, restart the engine and recheck the values. Repeat this procedure until the target values are achieved.
