SERVICE CAMPAIGN BULLETIN

TITLE:	Upper D Loop Seatbelt Securing Nut
CAMPAIGN REFERENCE	03Z
DOCUMENT NUMBER:	11 N 014
AFFECTED VEHICLES:	McLaren 675LT
SITUATION:	Quality Engineering at McLaren Automotive would like to inform retailers that customers may experience a rattle coming from the B-Pillar area. Retailers are required to check the torque of the upper D loop seatbelt securing nut.
PROCEDURE:	Please follow the procedure outlined in this document .

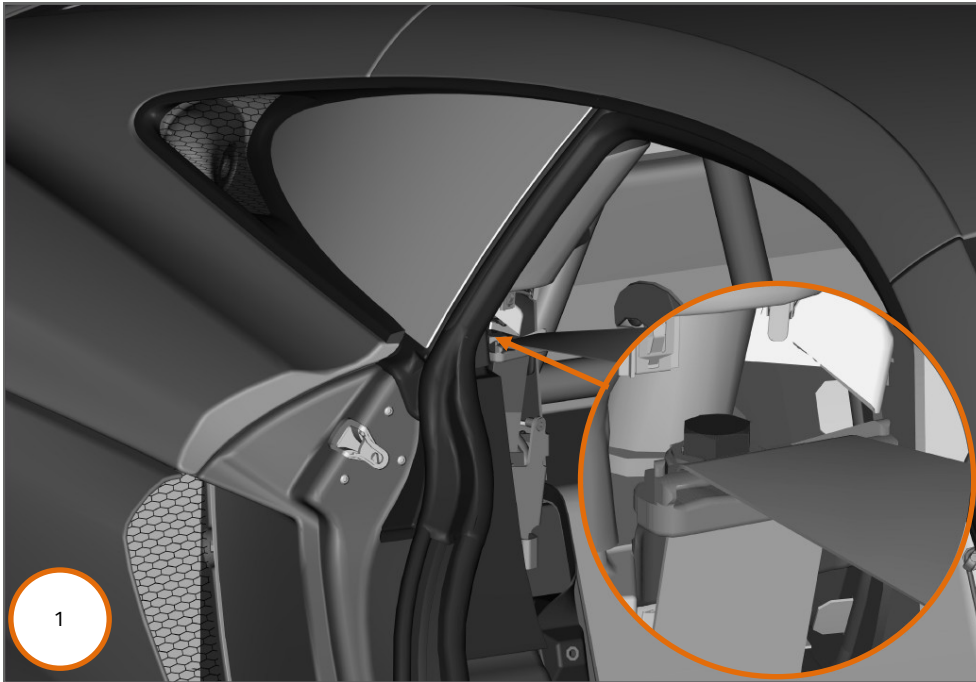
1. Check the D loop nut and bolt (1) is torqued to 35Nm on the drivers and passenger seat belts.

2. If torqued correctly no further action is required.
3. If torque is incorrect torque to 35Nm.
4. Install components in reverse order .
