Subaru Service and Technical Support Line Newsletter

August 2016

ARTICLES CONTAINED IN THIS ISSUE

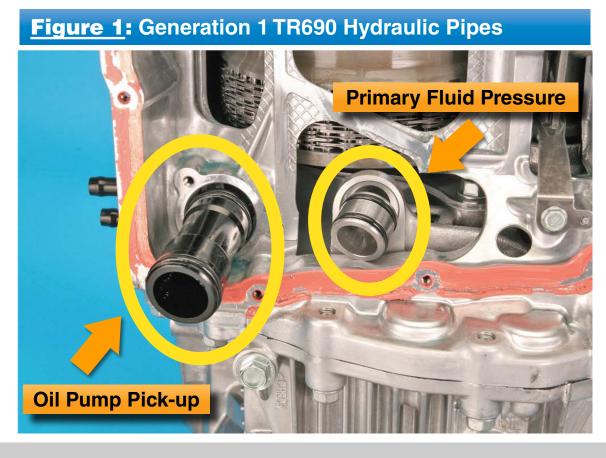
03 NO MOVEMENT AFTER VALVE BODY REPLACEMENT ON 10-12 LEGACY/OUTBACK CVT

Techline has received calls regarding no vehicle movement after valve body replacement on the first generation CVT (TR690). After investigation, it was determined the valve body was installed without transferring the primary pressure pipe. Loss of hydraulic fluid pressure will result along with several DTCs, most commonly P0841 and P2746. When removing and installing a new valve body, the primary fluid pressure pipe will need to be transferred to the new valve body. Typically, the pressure pipe will be found in the original valve body. New O-rings are required to be installed when the pressure pipe is removed during valve body service. Figure 1 shows the oil pump pick up and the primary fluid pressure pipes. Servicing the oil pump pick-up tube is not necessary, other than verifying it is fully seated into the CVT case. Refer to the applicable Service Manual for the valve body removal and installation instructions.
