**SERVICE PROGRAM BULLETIN**

**APPLICABILITY:** 2015-16 MY Legacy and Outback

**NUMBERS:** WTH-68

**SUBJECT:** Engine No-Start Condition in Cold Climates

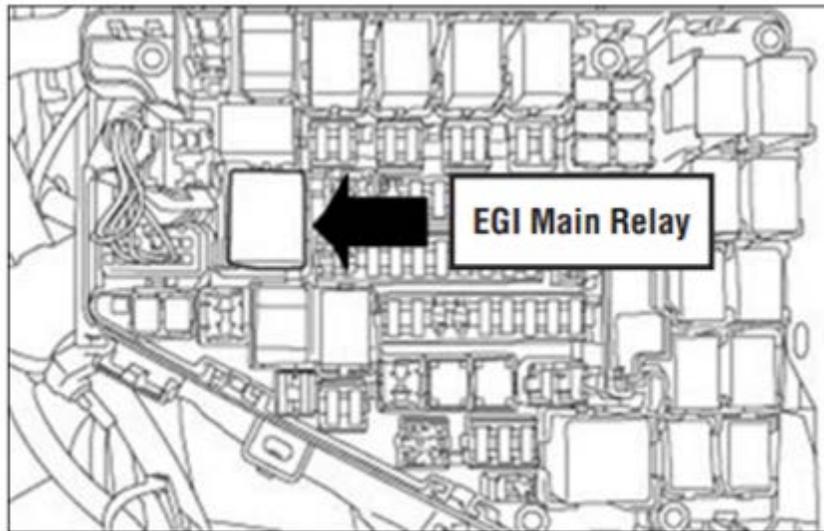
**Under-hood Main Fuse Box (M/B)**

The EGI Main Relay is located in the under-hood fuse box (M/B).

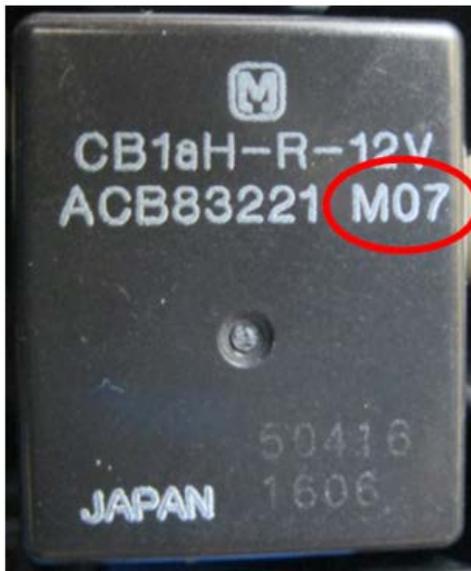
**OLD: M07**

During ocean transportation of the EGI Main relays, moisture may be absorbed into them from exposure to very high ambient humidity conditions. During normal operation, this moisture is heated by the relay’s electric coils and evaporated while the engine is running however, it may not all be eliminated. If the vehicle is used in extreme cold temperatures (-20C / -4F), ice crystals may form on the relay’s contacts due to rapid heat radiation after the engine is turned off. As a result, these ice crystals can insulate and prevent electricity from flowing and lead to a contact failure. Should this occur, the engine may fail to start immediately. For example: if the engine is started under extreme cold temperatures, shut-off and left to “soak” for approximately 20 minutes and then restarted, the described relay freezing / no-start condition may occur requiring several attempts to start the engine.

- Using the reference photos below as a guide, inspect the **EGI Main Relay** in the M/B. Replace the relay if inspection reveals **M07** on the top cover.
