GROUP Body	MODEL Forte KOUP (YD)
	NUMBER PS449	DATE April 2016

SUBJECT: FRAMELESS WINDOW SHORT DROP FEATURE INOPERATIVE

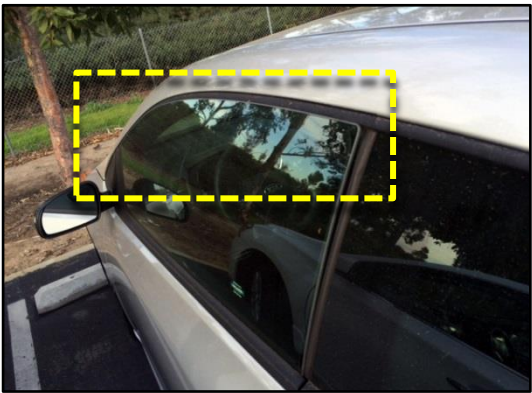
Some Forte Koup (YD) vehicles, produced before October 1, 2014, may experience difficulty when opening/closing the doors in freezing temperatures, due to the operation of the short drop feature as a result of frost/ice build-up between the window glass and outside belt molding. Normal operation of this feature involves the window lowering 0.4” (10mm) when the door is opened and raising to normal position when the door is closed. Due to extreme cold wintery conditions the customer may inquire with your dealer about its operation.

To address this condition, refer the customer to the procedure shown in the 2015MY Forte Owner’s Manual (Section 4, Page 29), or see below:

“If the window does not drop down automatically because ice has formed around it, tap lightly the windows to break the ice. Do not pry on the windows. If necessary, move the vehicle to a warm place and allow the ice to melt “.

If after performing the procedure described above, the customer continues to experience concerns in freezing temperatures, replace the belt line moldings for both driver and passenger sides with the parts number shown below.
