GROUP BOD	MODEL 2017MY Sportage (QL)
	NUMBER 136	DATE May 2016
TECHNICAL SERVICE BULLETIN		
SUBJECT: SERVICE ACTION: DOOR LATCH REPLACEMENT (SA229)

This bulletin provides the procedure to replace the door latches on certain Sportage (QL) vehicles, produced from December 10, 2015 through March 11, 2016, which may exhibit an intermittent illumination of the door ajar warning lamp. To prevent and/or correct this condition, replace both rear door latches with the improved parts, as described in this bulletin. Kia is requesting the completion of this Service Action on all affected vehicles, including dealer stock, prior to delivery. Before conducting the procedure, verify the vehicle is included in the list of affected VINs.

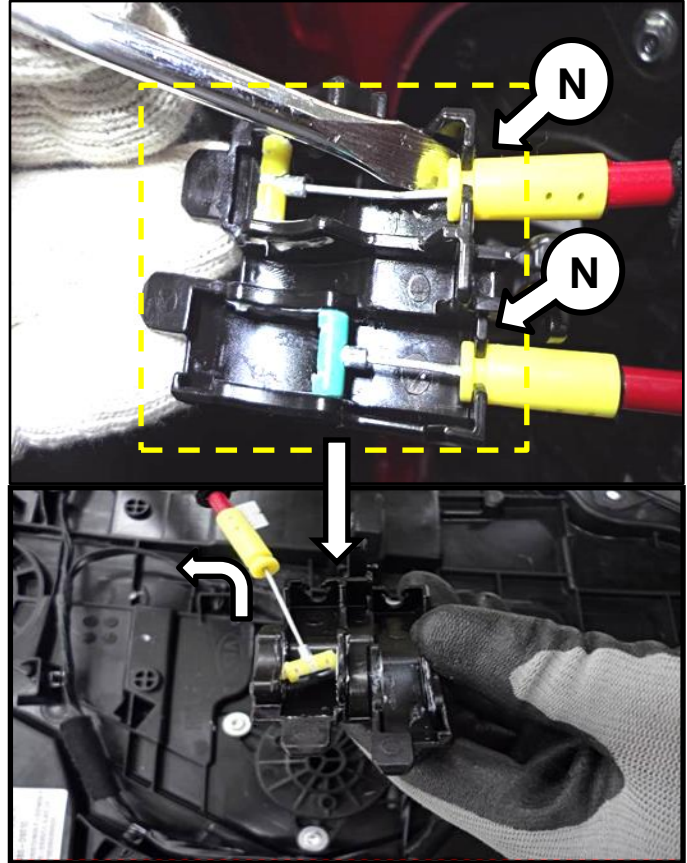
NOTE: Inspect the cage for damage. If found defective discard and replace with a new one.

15. Using a flathead screwdriver, remove the inside handle cage assembly from the inside handle cables (N). The cable ends will need to be rotated slightly to disengage the handle cage assembly.
