## SERVICE BULLETIN

<b>Reference number:</b>	<b>SB-17-0422</b>	<b>Issued: 04 February 2016</b>
<b>Subject:</b>	<b>Correct Installation of Rear Lamp Assemblies</b>	
<b>Models:</b>	<b>DB9, DBS, Rapide, Vantage and Virage</b>	
<b>VIN Range:</b>	<b>All</b>	
<b>Applicable to:</b>	<b>All Dealers</b>	
<b>Distribute to:</b>	<b>After Sales Manager</b> <b>Executive Manager</b> <b>Service Manager</b> <b>Sales Manager</b>	<b>Warranty</b> <b>Technician(s)</b> <b>Parts</b>

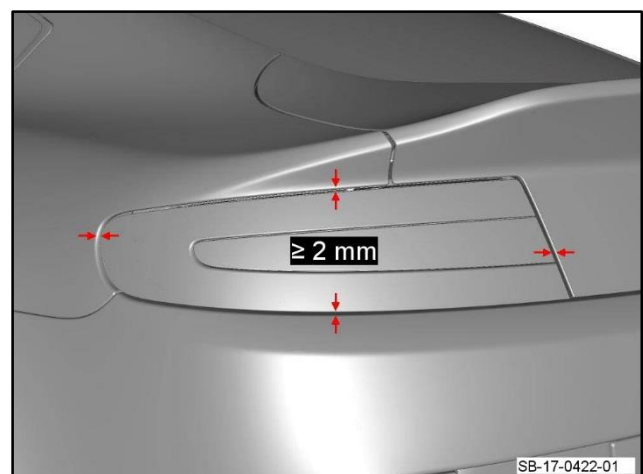
Figure 1

If there is not sufficient clearance between a rear lamp assembly and the adjacent bodywork, damage can occur. It is possible that vibration will cause the rear lamp assembly to touch the bodywork and rub against the paint.

1. There must be a gap a minimum of 2 mm wide between the rear lamp assembly and the adjacent body panels. This must be the same all around the rear lamp assembly (refer to Figure 1).

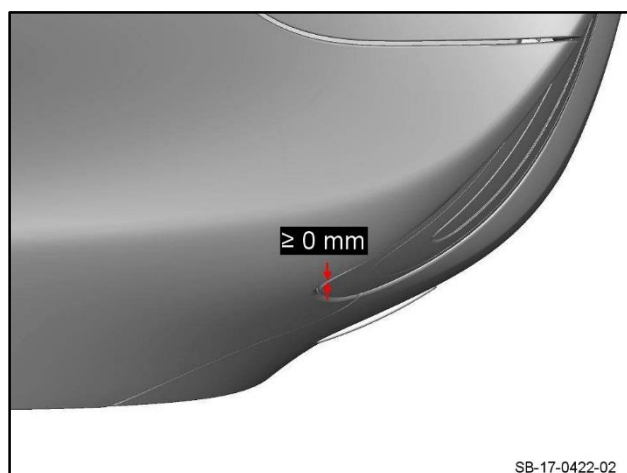
**Figure 2**

2. Make sure that the outboard tip of each rear lamp assembly is flush with, or a small distance above, the rear quarter panel (refer to Figure 2).

6. Turn the lamp sleeve adjuster at the applicable mounting until the adjuster is in the correct position. Make sure that the lamp sleeve adjuster is against the body. If there is a space between the body and the adjuster, damage will occur to the rear lamp assembly when you tighten the fasteners. A fastener that is tightened too much will pull the rear lamp assembly against the body and crack the assembly.

7. Install the rear lamp assembly and tighten the fasteners correctly. Make sure that the rear lamp assembly is set correctly relative to the rear quarter panel.

8. Do steps 6 thru 7 again until the rear lamp assembly is set correctly relative to the rear quarter panel.
9. When the rear lamp assembly alignment is correct, complete the installation of the assembly (refer to applicable Workshop Manual procedure 17.03.AA or 17.03.AB).

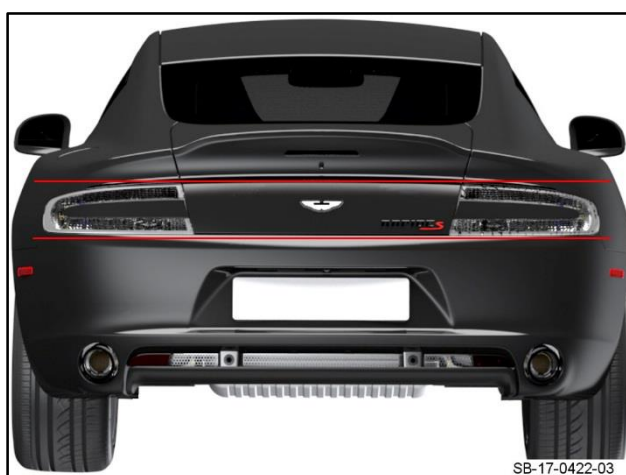
**Figure 3**

3. Make sure that the rear lamp assemblies are aligned symmetrically with each other (refer to Figure 3). Also make sure that the applicable edges of each lamp assembly align with the shut lines of the adjacent bodywork.

4. To align the rear lamp assembly, set the assembly to the correct position, then tighten the fasteners correctly.
5. To make the rear lamp assembly flush with the rear quarter panel, do the procedure that follows. The outboard tip of each rear lamp assembly must be flush with, or a small distance above, the rear quarter panel: do step 6 carefully at the applicable mounting.
