TECHNICAL SERVICE BULLETIN

Group:	11-ENGINE
Bulletin No:	SB-16-016
Issue Date:	7-14-2016
Reference:	HMM-160701-J2

DCU SOFTWARE UPDATE

SUBJECT VEHICLES: 13MY-17MY COE (Cab Over Engine) Trucks (155, 155h, 195, or 195h)

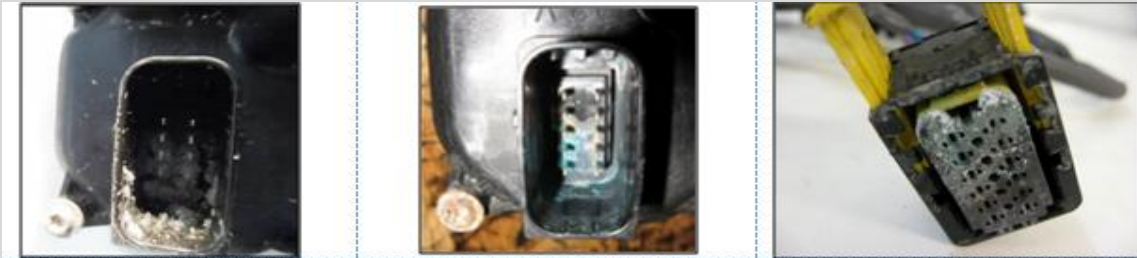
NOTICE: If corrosion is found in the DEF pump electrical connector and SCR harness connector, both the DEF pump and harness will require replacement.
