Service Bulletin

Subject: KNOCKING / SQUEAKING NOISE FROM FRONT SHOCK ABSORBER, CREAK- ING NOISE FROM FRONT LOWER ARM BUSHING	Bulletin No: 02-010/16
	Last Issued: 10/10/2016

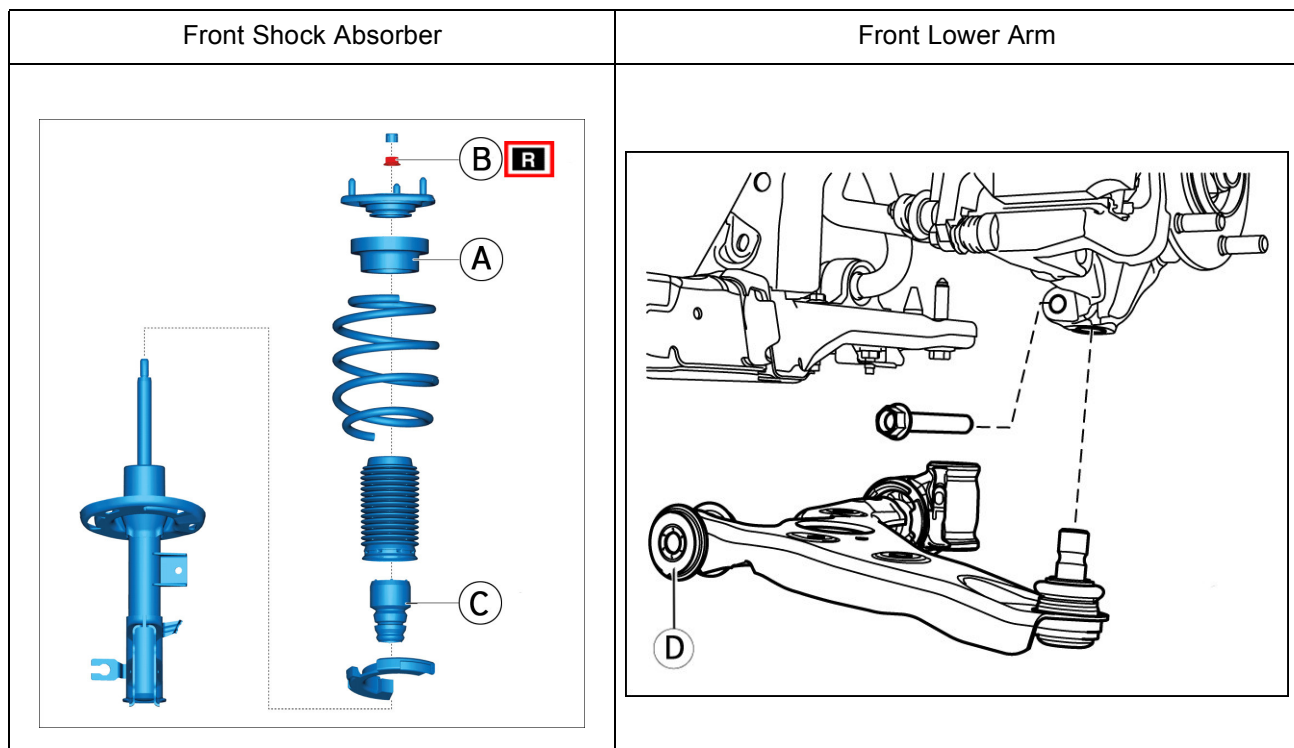
Some vehicles may exhibit a knocking / squeaking noise from the front shock absorber when driving on rough roads and/or when turning the steering wheel while the vehicle is stopped.

The noise may be due to:

- upper front strut bearing (A) damage. (CX-5 and Mazda6)
- stick/slip between the front strut bearing and coil spring. (CX-3, CX-5 and Mazda6)
- the bump stopper (C) may be contacting the strut bearing when the front shock absorber is compressed, causing a popping noise. (Mazda6 only)
- The front lower arm bushing (D) is making a stick-slip noise in wet road conditions. (CX-5 and Mazda6)

To eliminate the noise, the following mass-production changes have been made:

1. The material and production method of the front strut bearing (A) has been changed. (CX-5 and Mazda6)
2. A protector has been installed onto the coil spring. (CX-5 and Mazda6)
3. The shape of the bump stopper (C) will be modified in the future. (Mazda6 only)
4. The shape of the coil spring has been changed. (CX-3 only)
5. Friction of the lower arm bushing has been reduced by adding a dry coating. (CX-5 and Mazda6)

NOTE: The piston rod nut (B) requires replacement.

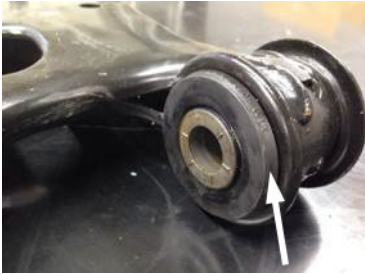
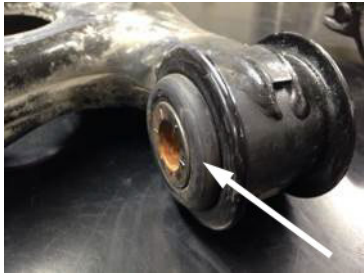
CAUTION: Make sure that the bushing has been properly inserted by checking that the tab of the bushing is completely expanded as shown in the OK illustration.

OK	NG
Tab is completely expanded	Tab is NOT completely expanded yet

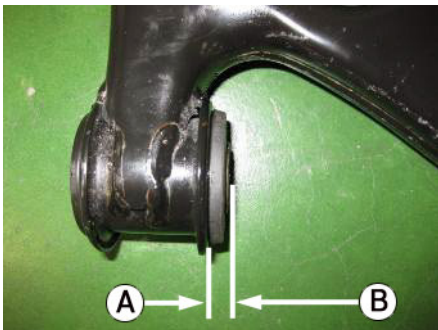
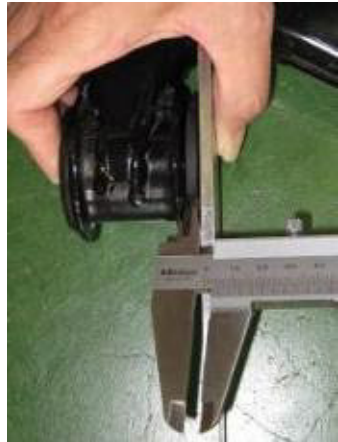
Specification: Width: 5.8 +/- 0.8mm (0.22 +/- 0.03 in)

Measure the distance of the lower arm end face (A) and the inner pipe bushing (B).		Measure the width as shown

4. After the installation, verify that the front lower arm bushing has been installed to the correct position by the procedure shown in the figure.
