Subject: 2013-2016 CX-5 AWD - KNOCKING NOISE FROM THE REAR OF THE VEHICLE	Bulletin No: 02-015/16
	Last Issued: 10/06/2016

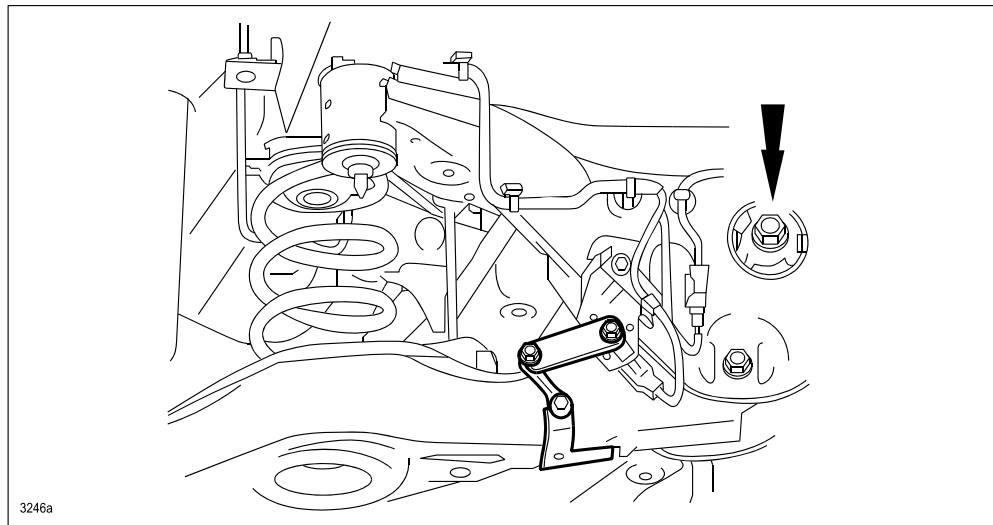
Some vehicles may exhibit a knocking noise from the rear of the vehicle. Upon inspection, cracks may be found in rear differential mount bushing, causing the noise. This is caused by insufficient durability of the bushing. To eliminate the noise, the shape of the bushing has been changed.

1. Verify the customer concern.
2. Replace the rear cross member with a modified one according to the instructions on MS3 online (REAR CROSSMEMBER REMOVAL/INSTALLATION [AWD]).
3. Verify the repair.
