Subject: RATTLE NOISE FROM FRONT DOOR GLASS	Bulletin No: 09-038/16
	Last Issued: 10/25/2016

2014-2016 Mazda3

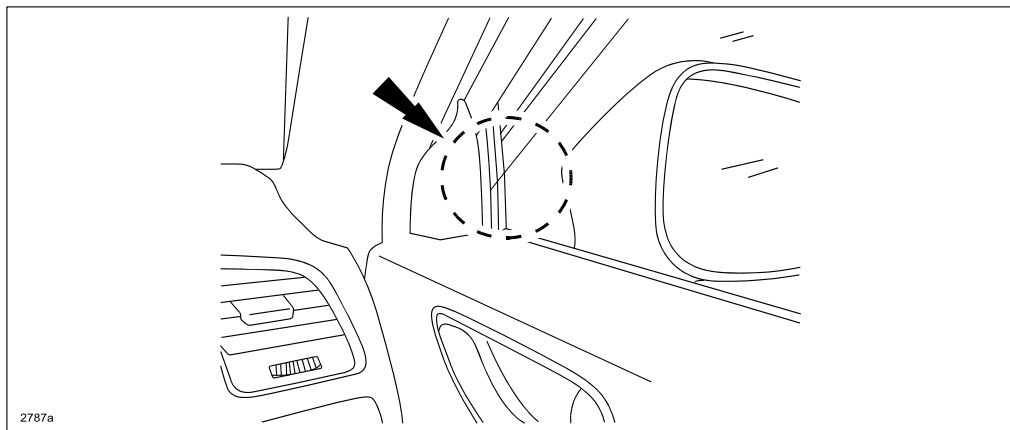
Some vehicles may experience a rattle noise from the front door glass when driving with the window open approx. 1/2 to 4 inches (1 - 10 cm).

The rattle noise may be caused by insufficient holding force of the glass run channel. To increase the holding force, the shape of glass run channel has been changed and non-woven pads have been attached to the glass run channel.

Customers having this concern should have their vehicle repaired using the following repair procedure.

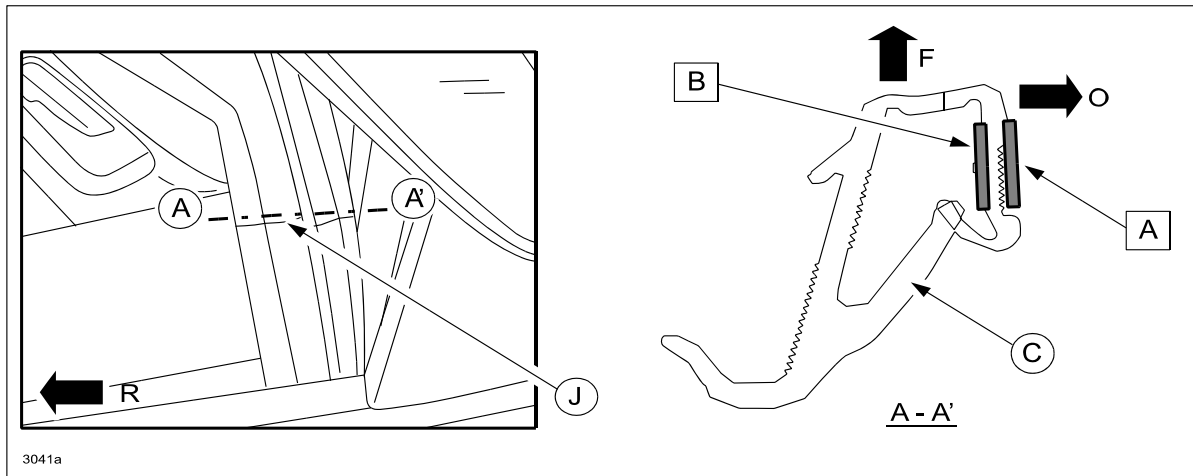
- Verify the customer concern. The rattle noise should go away when holding the slightly opened window by hand or when the window is completely closed.
 - If the noise goes away, proceed to the next step to attach non-woven pads to Positions A and/or B of the glass run channel (C) as shown below.

(O = Outer, F = Front, J = Molded Joint Line, R = Rear)
