© 2016 Mazda Motor of America, Inc.

Subject: 2016 CX-9 - CENTER CONSOLE LID RATTLES WHEN DRIVING ON ROUGH ROADS	Bulletin No: 09-052/16
	Last Issued: 10/06/2016

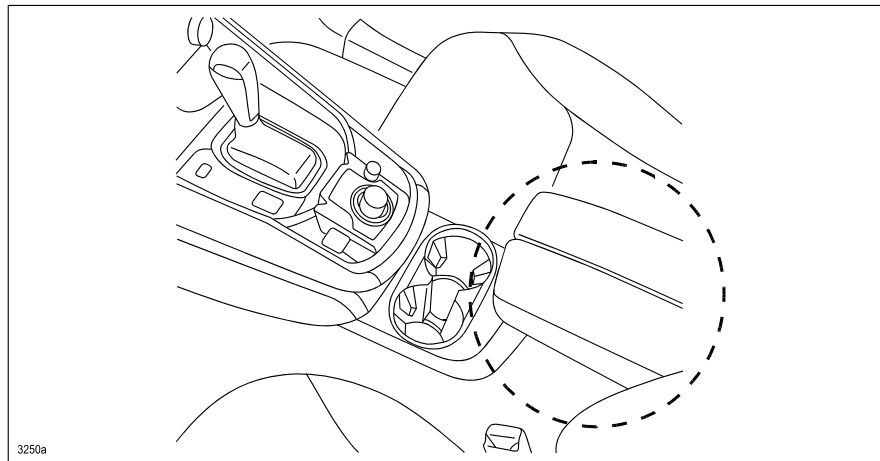
Some vehicles may exhibit a rattling noise from the center console lid while driving on rough roads or when an occupant leans onto the arm rest. Due to variations in the assembly and parts dimensions, some center console lids have play beyond the specifications, which causes a rattling noise. Urethane pads have been attached to the hinge arm of the center console lids to eliminate the noise.

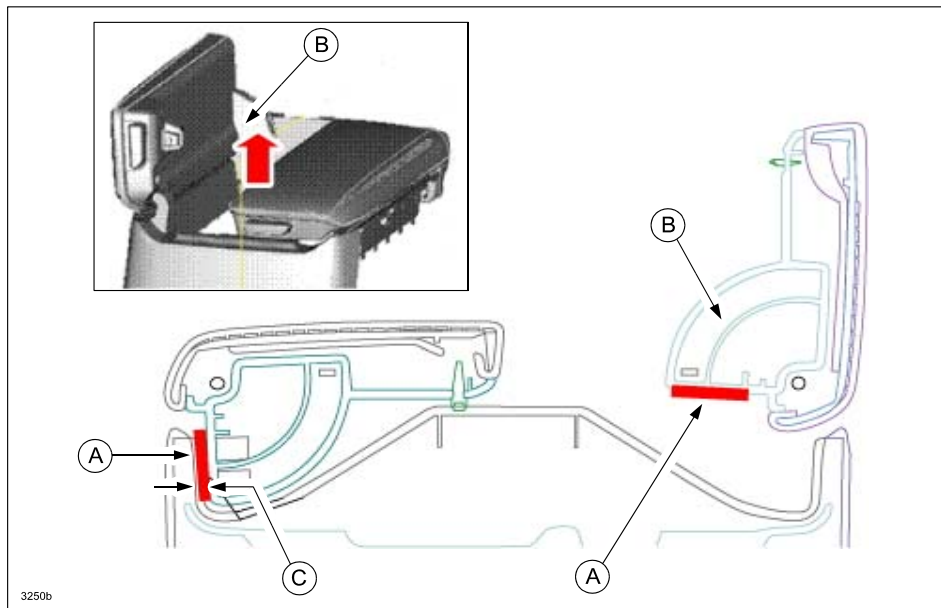
NOTE: The normal clearance when the lid is closed is 2 mm. Attaching the urethane pad decreases the clearance (C) and restricts rattling.

1. Verify the customer concern.
2. Open both center console lids.
3. Degrease the hinge arms (B) where the urethane pads (A) will be attached.
4. Peel off the backing film from the urethane pads (20 x 8 x 4 mm), then attach them to each hinge arm as shown below.
