Subject: CONVERTIBLE TOP TENSION BAND(S) DETACHED FROM HEADER PANEL AND HANGING DOWN	Bulletin No: 09-054/16
	Last Issued: 10/21/2016

2016-17 MX-5

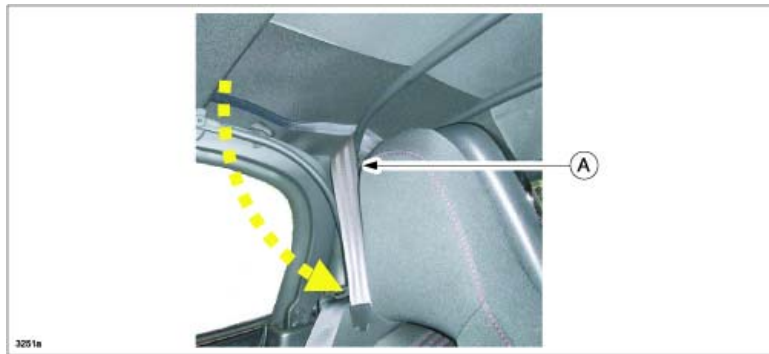
Some vehicles may exhibit the driver and/or passenger side tension band(s) (A) hanging down from the convertible top.

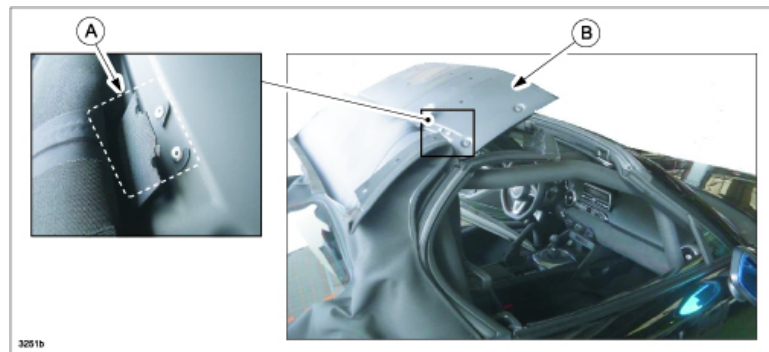
Upon inspection, the plastic plate (A) of tension band is broken where it is riveted to the header panel (B). This is caused by insufficient strength of the plastic plate. To correct this issue, the configuration of the tension band will be changed to increase the strength.

NOTE: The header panel is shown with the fabric top removed.

Customers having this concern should have their vehicle repaired using the following repair procedure.
