Subject: RATTLE NOISE FROM FRONT DOOR GLASS	Bulletin No: 09-055/16
	Last Issued: 10/25/2016

2014-2016 Mazda6 vehicles with VINs lower than JM1 GJ ***** 488592 (produced before June 30, 2016)

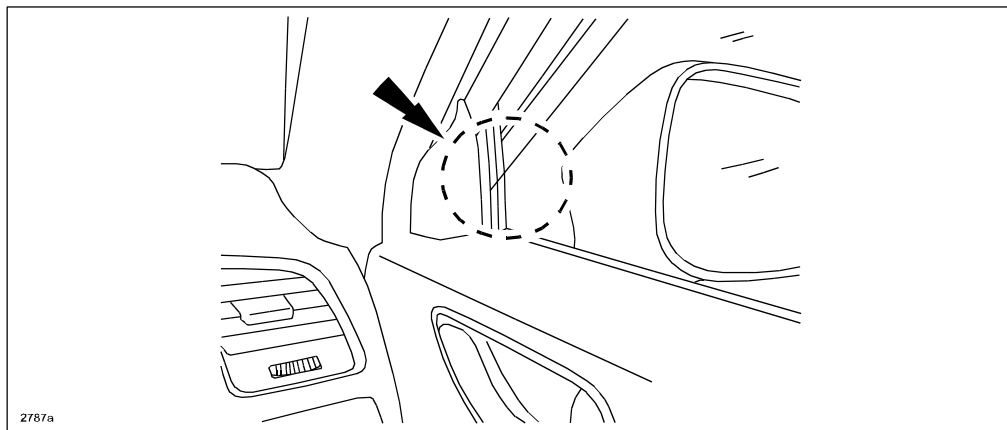
Some vehicles may experience a rattle noise from the front door glass when driving with the window open approx. 1/2 to 4 inches (1 - 10 cm).

The rattle noise may be caused by insufficient holding force of the glass run channel. To increase the holding force, the shape of glass run channel has been changed and non-woven pads have been attached to the glass run channel.
