Service Alert No: 1325

Title: 2016 CX-9 - THIRD ROW SEAT HEAD RESTRAINT IS NOT UPRIGHT

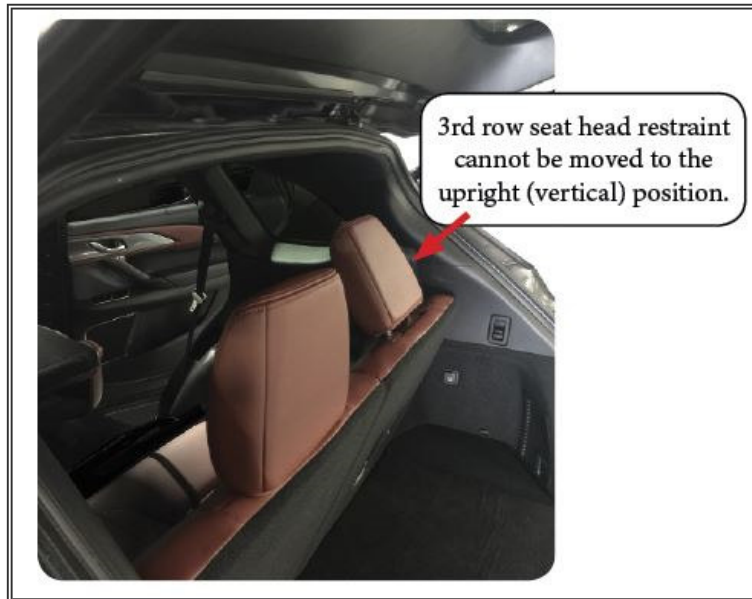
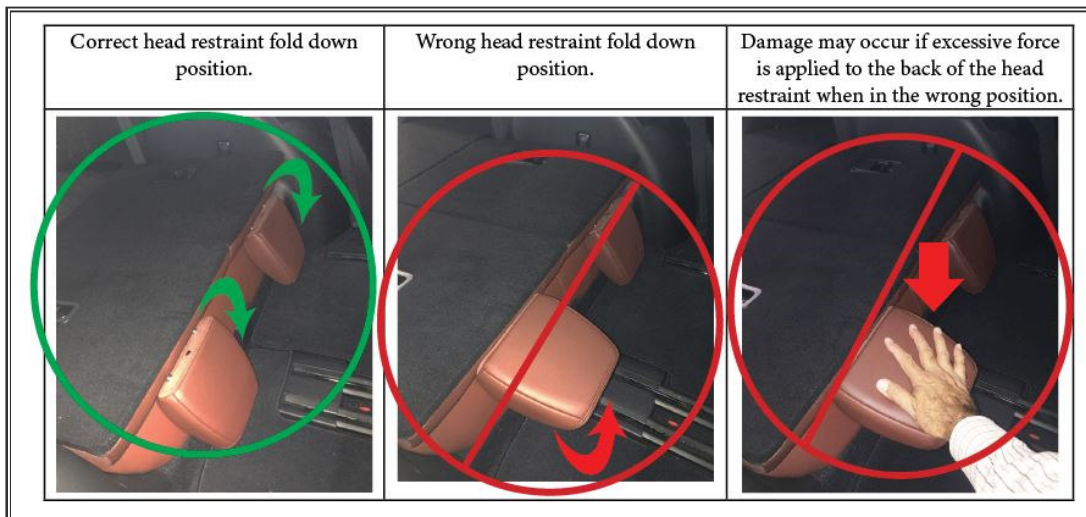
Some customers may complain about one or both third row seat head restraint(s) cannot be moved to the upright position. This may be caused by improper fold position of the head restraint(s) when the seat back is folded down.

Contact Hotline.
