## 2013 Roadster SE5 not shifting when engine is warm

### Summary:

In the event you encounter a 2013 Roadster SE5 that has difficulty or does not shift at all when the engine is at operating temperature follow the instructions listed below.

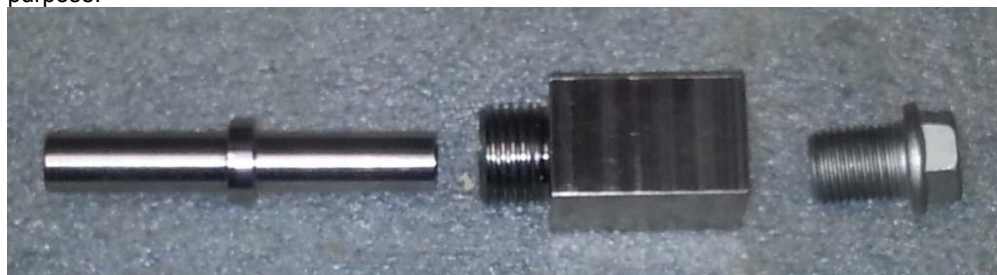
If you encounter a unit which does not shift or has difficulty shifting when the engine is at operating temperature. The problem may be related to the steel sleeve not pressed in all the way. Just the slightest gap between the sleeve and the HCM housing will allow the oil to seep past the regulator and not build up enough pressure to shift.

A tool has been developed to press the oil pressure regulator sleeve in position, tool part number 529 036 304. This tool should only be ordered if the unit presents the conditions leading to this TST's repair as the tool has only 1 purpose.
