Subject: SCRATCH ON SEAT BACK BAR GARNISH FROM CONTACT WITH CONVERTIBLE TOP	Bulletin No: 09-018/16
	Last Issued: 03/21/2016

2016 MX-5

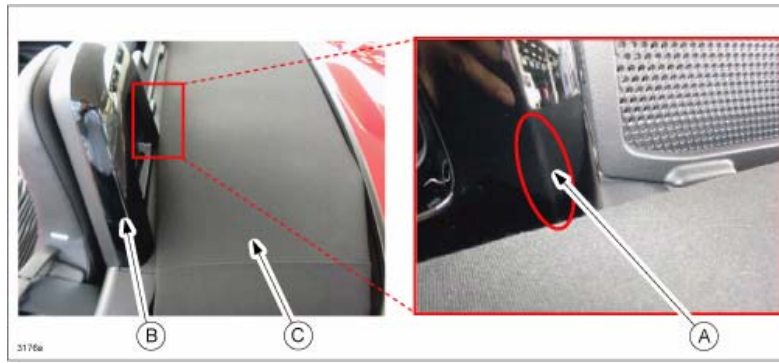
Some vehicles may exhibit scratches (A) on the rear of the seat back bar garnish (B) from contact with the convertible top (C).

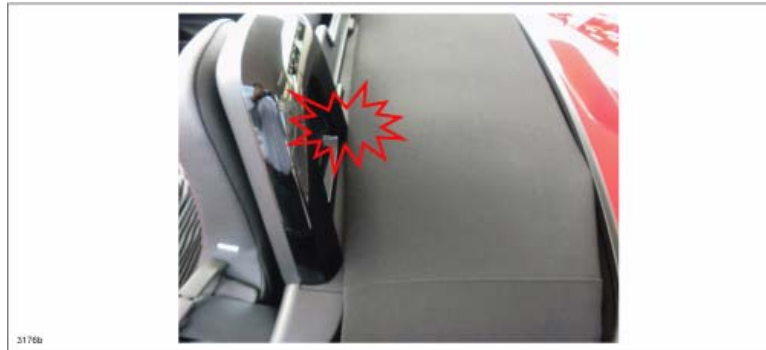
Due to assembly variations, the clearance between the seat back bar garnish and the convertible top is too small on some vehicles.
