© 2016 Mazda Motor of America, Inc.

Subject: NO COOL AIR FROM AIR CONDITIONER (LEAK FROM EVAPORATOR)	Bulletin No: 07-005/16
	Last Issued: 12/05/2016

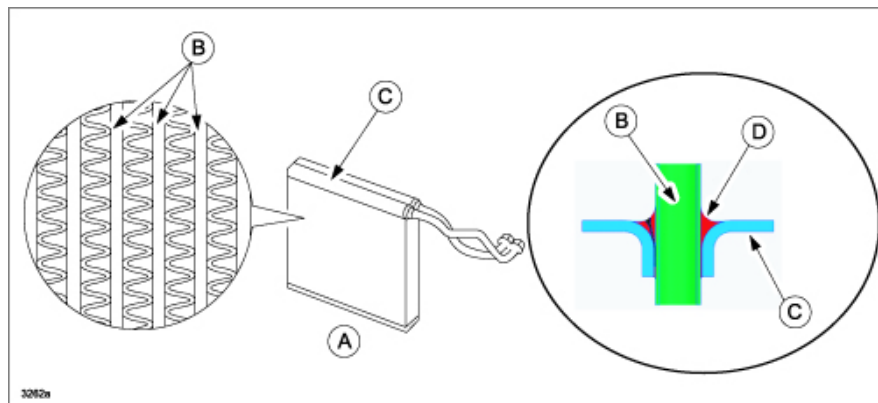
Some customers may complain about no cool air from the vents when the air conditioner (A/C) is ON. This concern may be caused by A/C refrigerant leaking from the evaporator (A) at the joint between the tubes (B) and the header (C) due to improper brazing (D). To correct the problem, the configuration of the header has been changed to improve the brazing performance in this area.

Customers having this concern should have their vehicle repaired using the following repair procedure.

1. Verify customer concern.
2. Verify that the level of A/C refrigerant charge is low (The A/C refrigerant high and low pressures are both low).
3. Check for refrigerant leakage from any part of the system, using a colored dye.
 - If leakage is found from the A/C unit drain hose, check the A/C unit inside. If leakage is detected from the evaporator, replace it with a modified one according to the instructions on MS3 online (A/C UNIT DISASSEMBLY/ASSEMBLY).

NOTE: When replacing the evaporator, add approximately 40 ml {40 cc, 1.4 fl oz} of compressor oil according to the instructions on MS3 online (A/C COMPRESSOR REMOVAL/INSTALLATION).
 - If leakage is found from other than evaporator, repair or replace it according to the instructions on MS3 online.
4. Verify repair.
