<b>Subject:</b>  A/C BLOWS WARM AIR	<b>Bulletin No:</b> 07-006/16
	<b>Last Issued:</b> 12/12/2016

2016 Mazda2 vehicles with VINs 3MD DJ \*\*\*\*\* 100050 through 108941 (produced from December 19, 2014 through July 31, 2016)

2016 CX-3 USA/Mexico vehicles with VINs JM1 DK \*\*\*\*\* 103784 through 151377 (produced from June 01, 2015 through July 31, 2016)

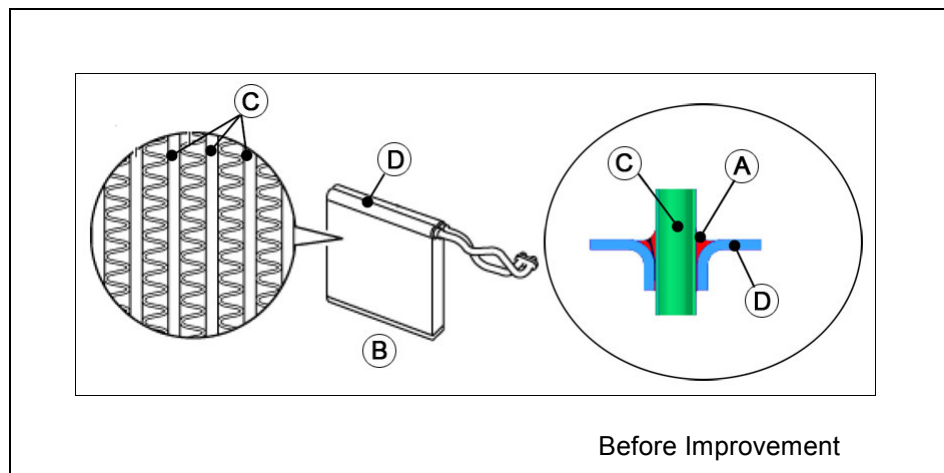
Some customers may complain about warm air from the climate control vents. This may be caused by improper brazing (A) of the evaporator (B), causing a refrigerant leak from the joint between the tubes (C) and the header (D).

- Yes - Go to step 4.
  - No - This Service Information is not applicable. Refer to MS3 online Workshop Manual NO COOL AIR [FULL-AUTO AIR CONDITIONER].
4. Replace the A/C evaporator. Refer to MS3 online Workshop Manual A/C UNIT REMOVAL/INSTALLATION.

**NOTE:** When replacing the evaporator, add compressor oil of approximately 40 ml {40 cc, 1.4 fl oz}. Refer to MS3 online Workshop Manual REFRIGERANT CHARGING.
5. Verify repair.

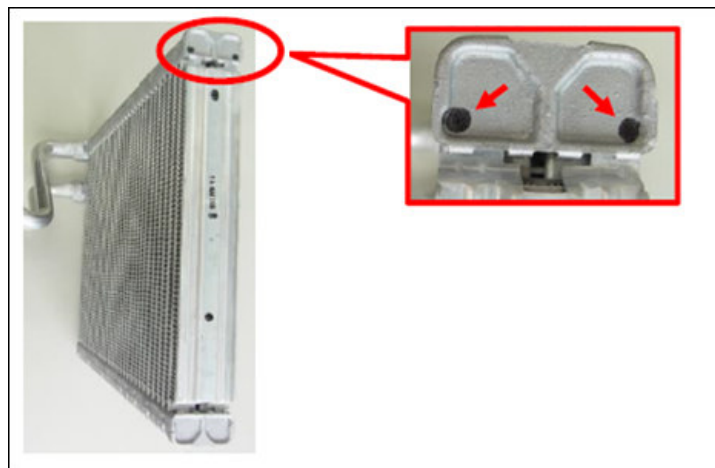
**NOTE:** Modified part can be distinguished by its black circled marking as shown below.
