Subject: AIR INTAKE MODE DOES NOT WORK AFTER REPAIR OF RAIN SENSOR, FBCM, IC, PCM OR TCM	Bulletin No: 07-007/16
	Last Issued: 12/13/2016

APPLICABLE MODEL(S)/VINS

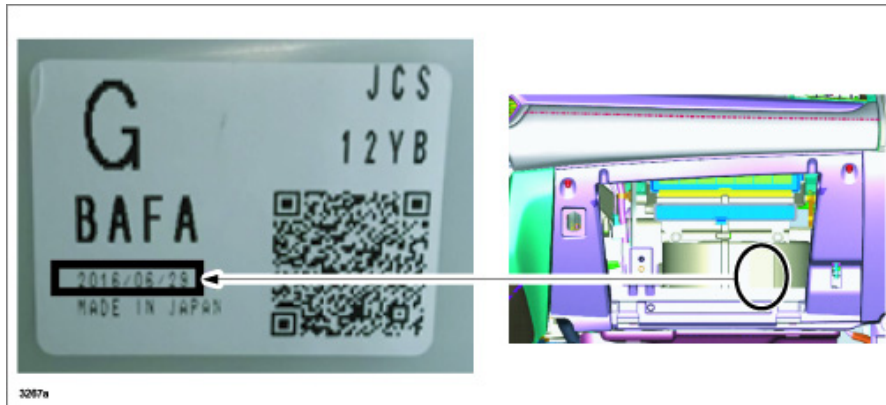
NOTE: If the date code (YYYY/MM/DD) on the blower unit is the following date or later, it is already modified.

Date Code: Mazda3 - 2016/07/11, Mazda6 - 2016/07/12

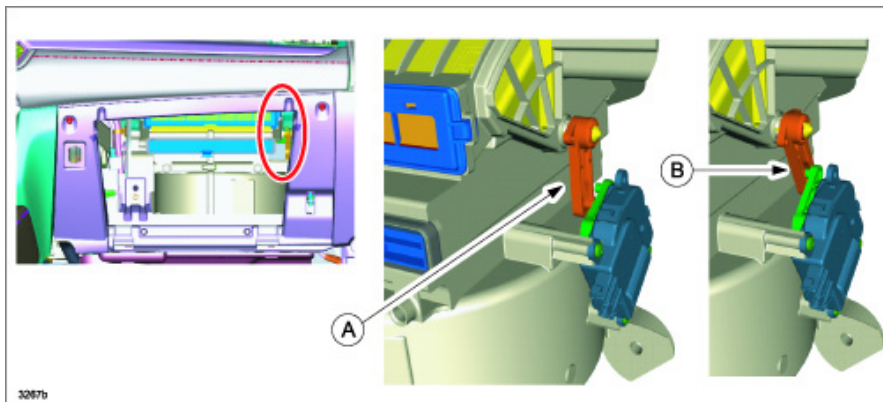
1. Verify the customer concern
2. Remove the glove box according to the instructions on MS3.
Mazda3 (GLOVE COMPARTMENT REMOVAL/INSTALLATION).
Mazda6 (GLOVE COMPARTMENT REMOVAL/INSTALLATION).
3. Check if the air intake link is disengaged (A) or engaged (B) as shown.

- If the air intake link is disengaged, replace the blower unit with a modified one according to the instructions on MS3.
Mazda3 (BLOWER UNIT REMOVAL/INSTALLATION).
Mazda6 (BLOWER UNIT REMOVAL/INSTALLATION).

NOTE: Forcing the link back into engagement may result in damage to other parts.

- If the air intake link is not disengaged, troubleshoot the HVAC system according to the instructions on MS3.
4. Verify the repair
