| <b>Subject:</b><br><b>CONVERTIBLE TOP TENSION BAND(S) DETACHED FROM HEADER PANEL<br/>AND HANGING DOWN</b> | <b>Bulletin No:</b> 09-054/16 |
| | <b>Last Issued:</b> 12/19/2016 |

2016-2017 MX-5 vehicles with VINs lower than JM1ND\*\*\*\*H\*121455 (produced before September 23, 2016)

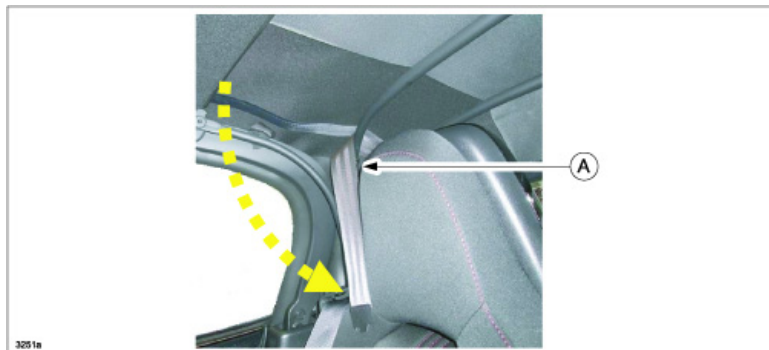
Some vehicles may exhibit the driver and/or passenger side tension band(s) (A) hanging down from the convertible top.

Customers having this concern should have their vehicle repaired using the following repair procedure.

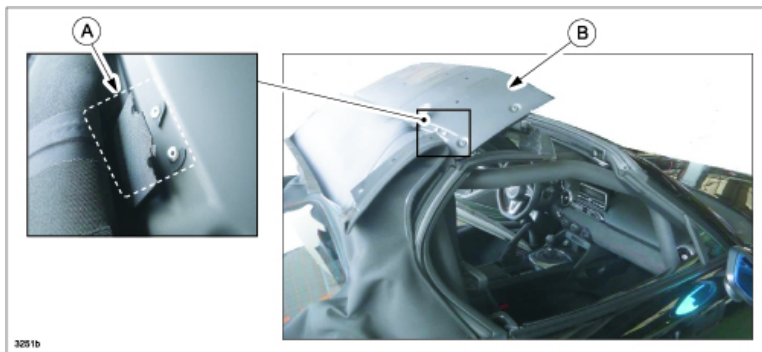
Upon inspection, the plastic plate (A) of tension band is broken where it is riveted to the header panel (B). This is caused by insufficient strength of the plastic plate. To correct this issue, the configuration of the tension band will be changed to increase the strength.

**NOTE: REPAIR BOTH SIDES EVEN WHEN IT IS BROKEN AT ONE SIDE ONLY.**

1. Remove the broken plastic plate (A) from the tension band (B).
2. Push two holes in the tension band and the header panel (C) respectively at the specified positions.
3. Attach the tension band to the header panel with two rivets and washers (D).
