<b>Subject:</b>  SECOND-ROW SEAT WALK-IN LEVER DOES NOT WORK	<b>Bulletin No:</b> 09-060/16
	<b>Last Issued:</b> 12/01/2016

2016 CX-9 vehicles with VINs lower than JM3KE\*\*\*\*\*118947 (produced before September 1, 2016)

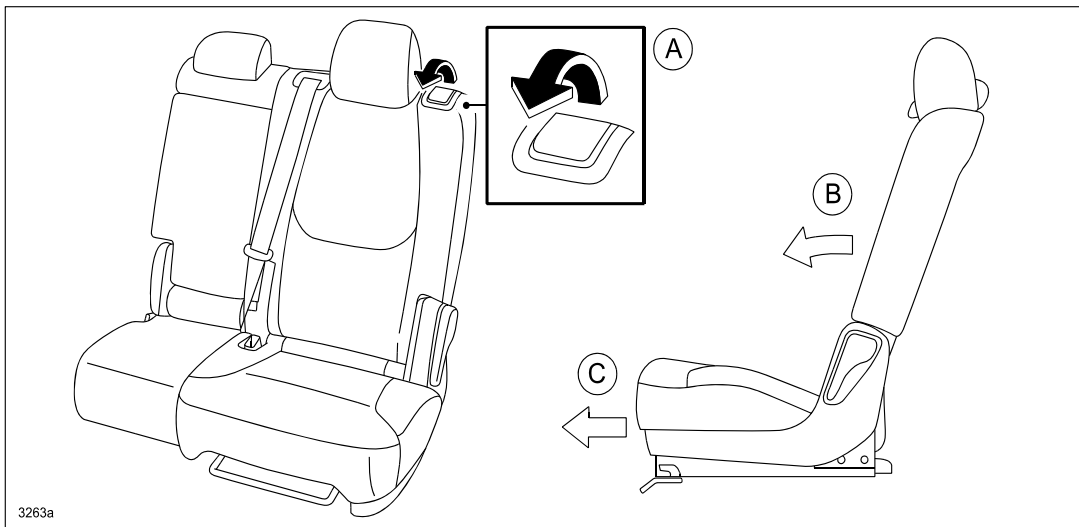
On some vehicles, the second-row seat back does not fold (B) or slide (C) forward when the walk-in lever (A) is pulled up to access to the 3rd row seats.

This concern may be caused by a disconnected walk-in lever cable. The design of the walk-in lever has been changed to reduce the force applied to the cable.

Customers having this concern should have their vehicle repaired using the following repair procedure.

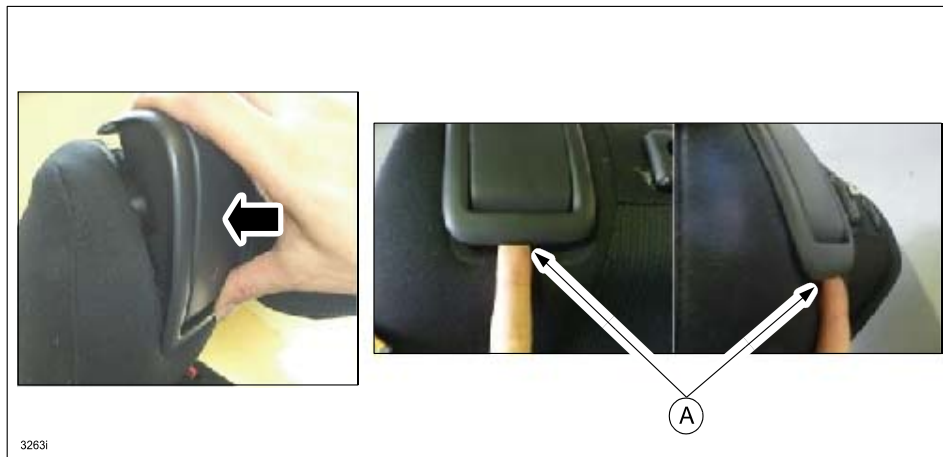
**NOTE:** The example shown below (A) is NO GOOD. There should not be any clearance.

3. Push the lever assembly into the seat back, verifying that the front edge is securely engaged in the anchor.
