Subject: Fctry MESSAGE DISPLAYED AFTER INSTRUMENT CLUSTER REPLACEMENT	Bulletin No: 09-061/16
	Last Issued: 12/02/2016

2016-2017 Mazda2	2016-2017 CX-3
2014-2017 Mazda6	2016-2017 CX-9

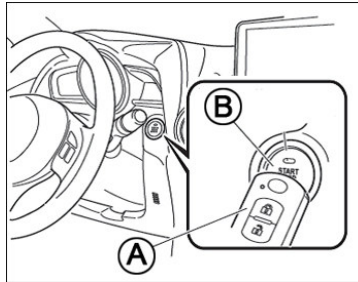
After the installation of a new instrument cluster, the message “Fctry” is displayed instead of the odometer. Some new instrument clusters are in the factory mode setting. Factory mode cancellation is required.

1. Verify concern.
2. Remove the room fuse.
3. Use the back side of the key (A) to press the start button (B) to turn the ignition ON.

4. Press the start button (B) to turn the ignition OFF.
5. Install the room fuse.
6. Verify the Fctry message is no longer present.
