Subject: CHECK ENGINE LIGHT ON WITH DTC P0300-P0304	Bulletin No: 01-014/16
	Last Issued: 09/22/2016

DESCRIPTION

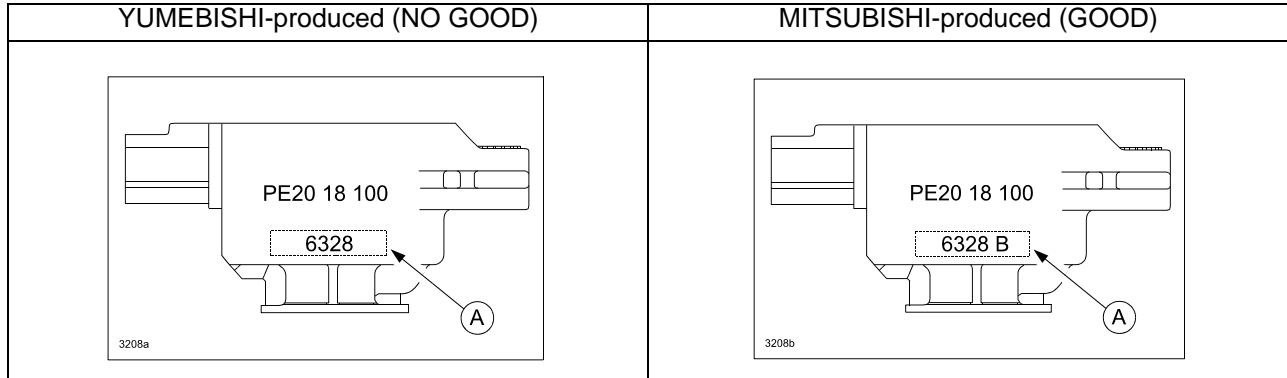
NOTE: The ignition coils are supplied from two different vendors, YUMEBISHI and MITSUBISHI. This concern only occurs on YUMEBISHI- produced ignition coil.

To distinguish between YUMEBISHI and MITSUBISHI ignition coils, look at their lot numbers (A). YUMEBISHI have 4 digit lot numbers and MITSUBISHI have 5 digit lot numbers as shown.

6	Year (4=2014, 5=2015, 6=2016)
3	Month (1=Jan, 2=Feb, 3=Mar...X=Oct, Y=Nov)
2	Day
8	
B	MITSUBISHI-produced only (A=Daytime, B=Nighttime)

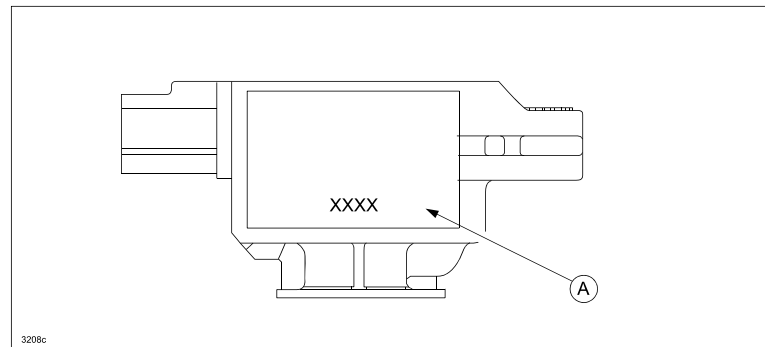
NOTE: There is no part number change. Differentiate the new modified ignition coil (YUMEBISHI-produced) from the old one by the lot number on the ignition coil. Ignition coils with the lot number of 6328 (March 28, 2016 production) or higher are modified.

4. Check if any of the other non-defective coils are YUMEBISHI-produced and made before lot number 6328 (March 28, 2016 production). If any were made before this date, replace them with modified one(s) as well.
