<b>Subject:</b> <b>WARNING LIGHT ON WITH DTC P1887:11 - 14 AND/OR NOISE FROM COUPLING UNIT</b>	<b>Bulletin No:</b> 03-004/16
	<b>Last Issued:</b> 09/09/2016

2013-2016 CX-5 AWD vehicles with VINs lower than JM3KE\*\*\*\*\*837718 (produced before July 1, 2016)

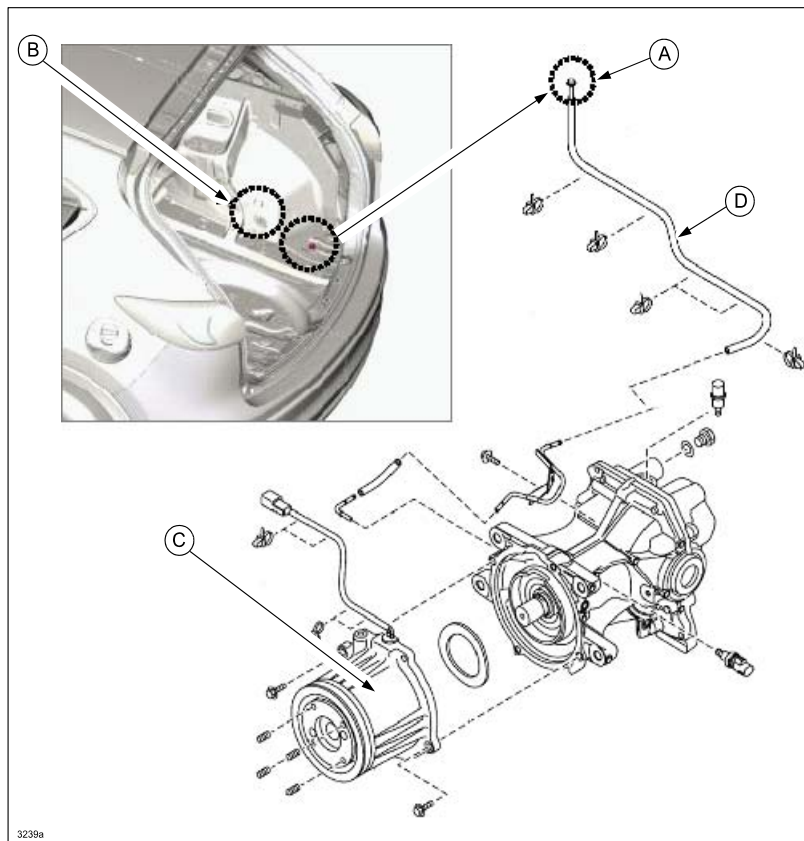
The breather pipe grommet (A), located in the trunk, may be submerged in water that penetrated through the rear ABS wheel-speed sensor harness grommet (B) during a high pressure car wash. The water then enters the coupling unit (C) through the breather pipe (D). This creates rust inside the coupling unit, which causes internal wiring harness damage, setting the DTC and/or the coupling unit noise due to increased rotational resistance.

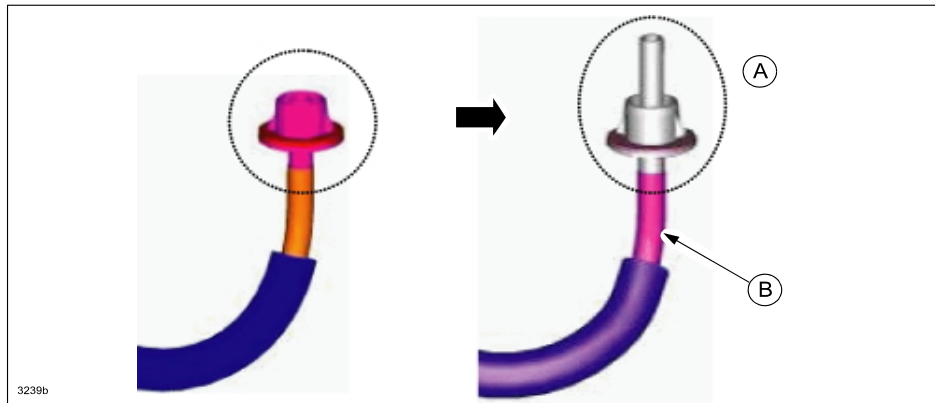
The configuration of the breather pipe grommet (A) has been changed to prevent water from entering the breather pipe (B), even if water accumulates in the trunk.

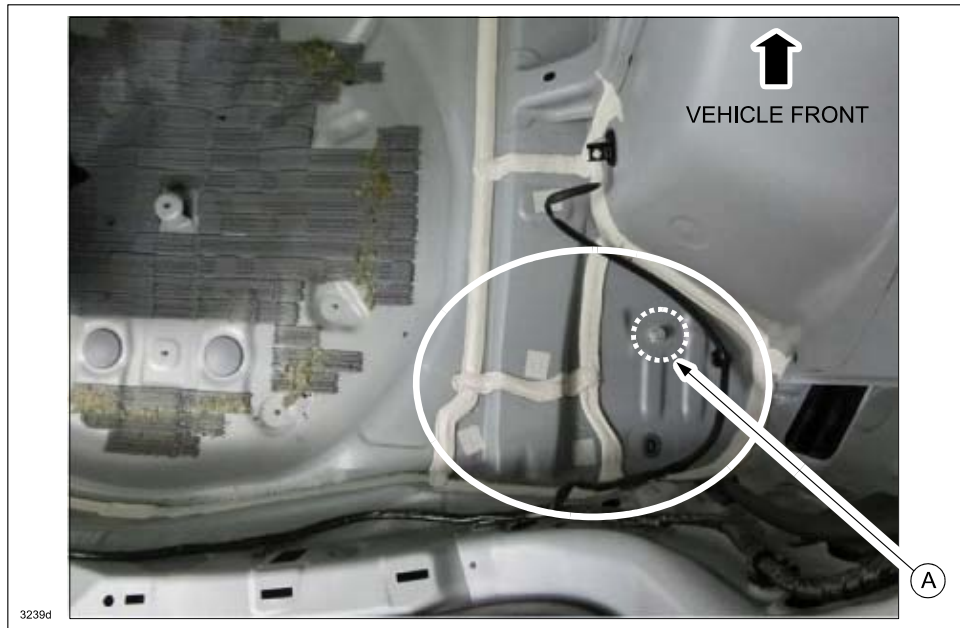
3. Check inside the trunk around the breather pipe grommet (A) for traces of water/moisture.

- If there is any trace of water/moisture around the breather pipe grommet, go to the next step.
- If there is no trace of water/moisture around the breather pipe grommet, this service information is not applicable. Refer to the instructions on MS3 online for further troubleshooting procedures.

4. Remove and dry any existing water/moisture from the area.

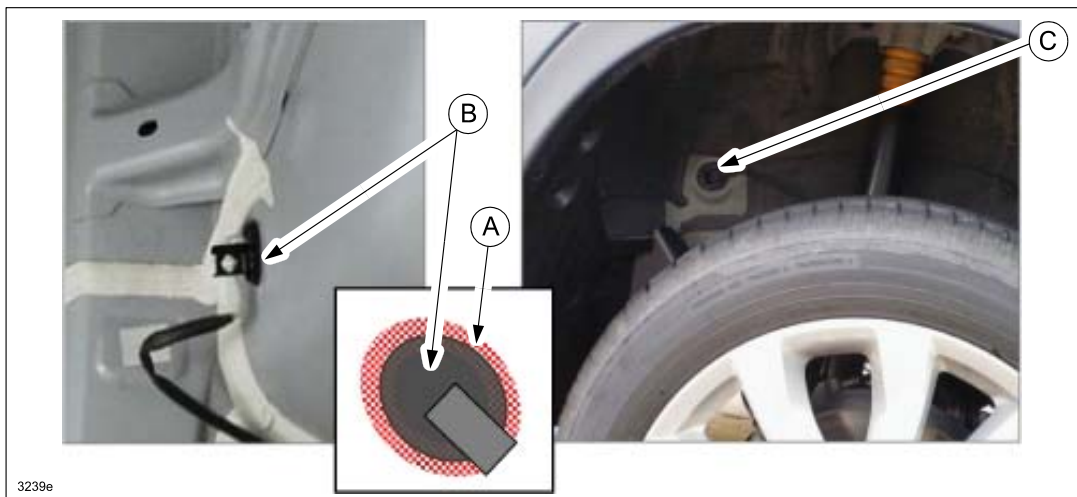
**NOTE:** This step prevents water from penetrating through the ABS sensor grommet (C) during high pressure car washing around the rear wheel arch.

5. Apply butyl tape (A) around the ABS wheel-speed sensor harness grommet (B) to seal between the grommet and the body panel.
