Subject: AIR TEMPERATURE WILL NOT CHANGE	Bulletin No: 07-003/16
	Last Issued: 09/13/2016

2014-15 Mazda3 (Japan built with manual A/C) with VINS lower than JM1BM*****247593 (produced before December 1, 2014)

2014-16 Mazda3 (Mexico built with manual A/C) with VINS lower than 3MZBM*****317865 (produced before July 6, 2016)

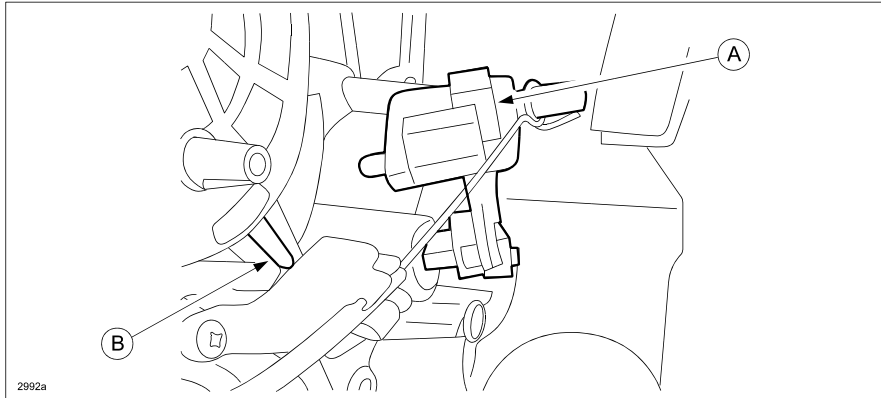
Some customers may complain that the air temperature from the air conditioner will not change with the air temperature control knob, and may be accompanied by some rattle noise from behind the dash board. This concern may be caused by the temperature control link being pulled out of the HVAC housing. To correct the problem, the temperature control link has been modified.

1. Verify customer concern.
2. Refer to the instructions on MS3 online or the Workshop Manual (section 07-40 CLIMATE CONTROL UNIT REMOVAL/INSTALLATION [MANUAL AIR CONDITIONER]) and check that the MIX LINK (Air mix link/Temperature control link) (A) is properly connected to the MIX DOOR CRANK (B) and works while rotating the temperature control knob.

- a. If it works, this Service Bulletin does not apply. Refer to the instructions on MS3 online or Workshop Manual for troubleshooting and repair.
- b. If the MIX LINK is detached, proceed to the next step.
