Subject: AIR TEMPERATURE WILL NOT CHANGE	Bulletin No: 07-003/16
	Last Issued: 09/28/2016

2014-15 Mazda3 (Japan built with manual A/C) with VINS lower than JM1BM*****247593 (produced before December 1, 2014)

2014-16 Mazda3 (Mexico built with manual A/C) with VINS lower than 3MZBM*****317865 (produced before July 6, 2016)

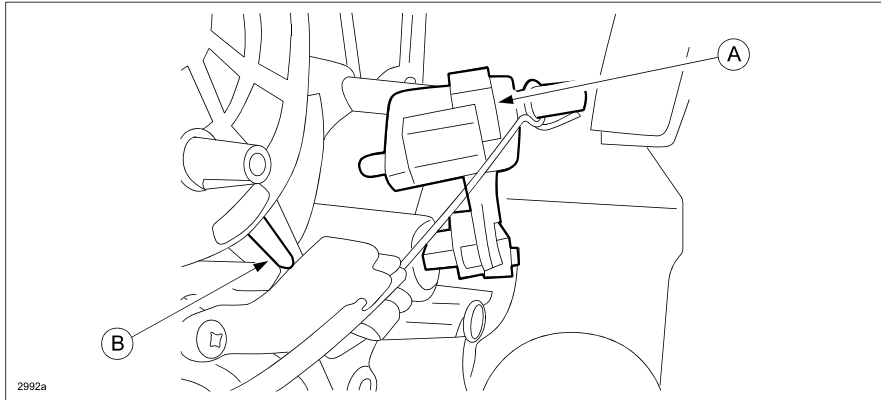
Some customers may complain that the air temperature from the air conditioner will not change with the air temperature control knob, and may be accompanied by some rattle noise from behind the dash board. This concern may be caused by the temperature control link being pulled out of the HVAC housing. To correct the problem, the temperature control link has been modified.

1. Verify customer concern.
2. Refer to the instructions on MS3 online or the Workshop Manual (section 07-40 CLIMATE CONTROL UNIT REMOVAL/INSTALLATION [MANUAL AIR CONDITIONER]) and check that the MIX LINK (Air mix link/Temperature control link) (A) is properly connected to the MIX DOOR CRANK (B) and works while rotating the temperature control knob.

- a. If it works, this Service Bulletin does not apply. Refer to the instructions on MS3 online or Workshop Manual for troubleshooting and repair.
 - b. If the MIX LINK is detached, proceed to the next step.
3. Japan built vehicles:
Replace the MIX LINK with a modified one. Refer to MS3 online (A/C UNIT DISASSEMBLY/ASSEMBLY). Make sure that the MIX LINK is fitted in the groove of the MIX DOOR CRANK and will not come out with movement.

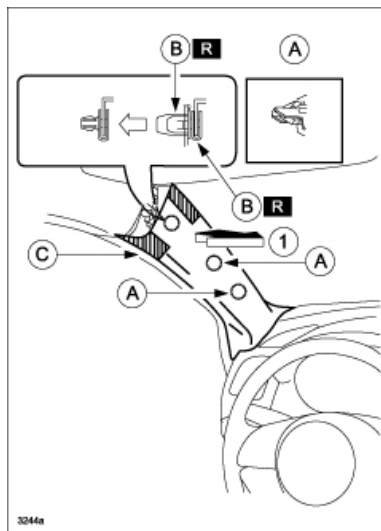
Clip (A) and Clip (B) of A-pillar trim (C)

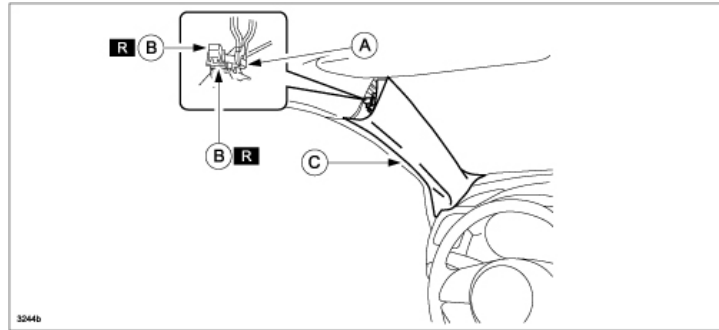
Grommet (B) for Lead Wire (A) by A-pillar trim (C)

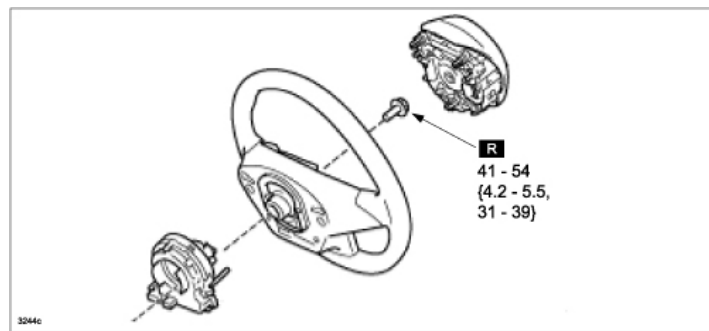
Lockbolt for Steering Wheel (A)

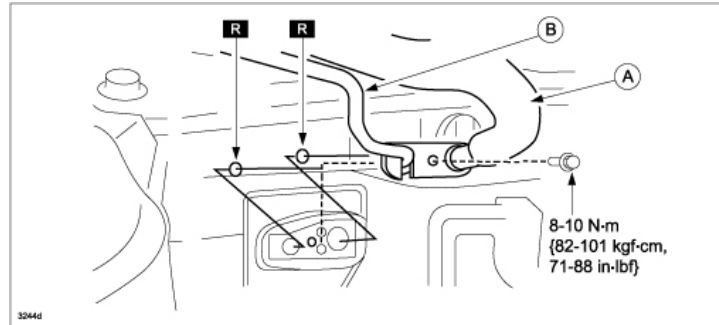
O-rings for Cooler Hose (LO) (A) and for Cooler Pipe (B)

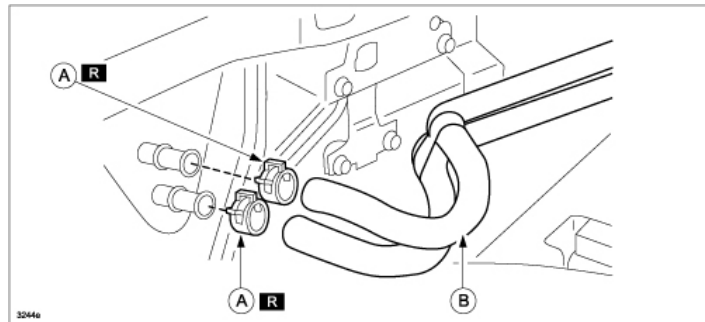
Clips for Heater Hose (A)

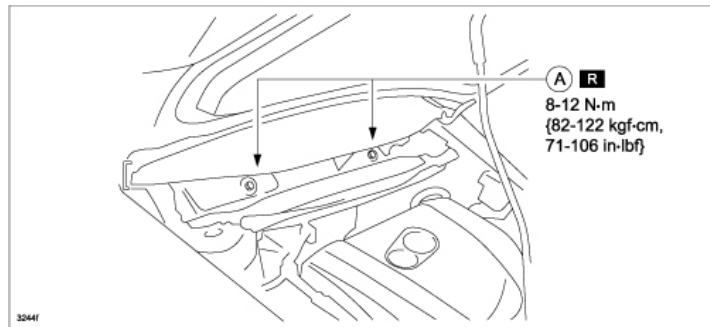
Bolt for Dashboard (A)
