Subject: RUST/PAINT BLISTER ON TRUNK LID AROUND LICENSE PLATE LIGHT	Bulletin No: 09-037/16
	Last Issued: 09/13/2016

2014-2016 Mazda3 (Japan built) vehicles with VINs lower than JM1BM*****351834 (produced before May 16, 2016)

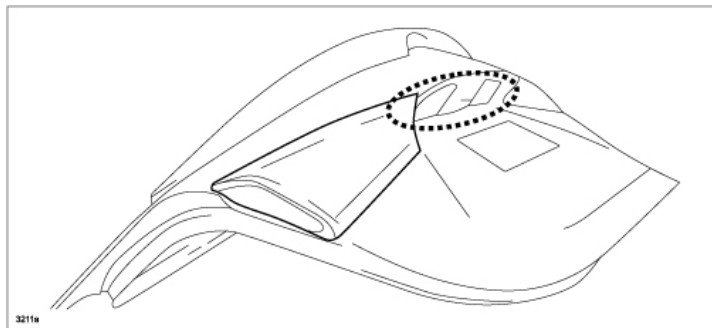
Some vehicles may exhibit rust/paint blister on the trunk lid around the license plate lights.

1. Verify the customer concern
2. Repair the concern using ordinary bodyshop rust/paint blister damage procedures.

NOTE: Repair affected area(s) only. There is no need to repaint the whole trunk lid.

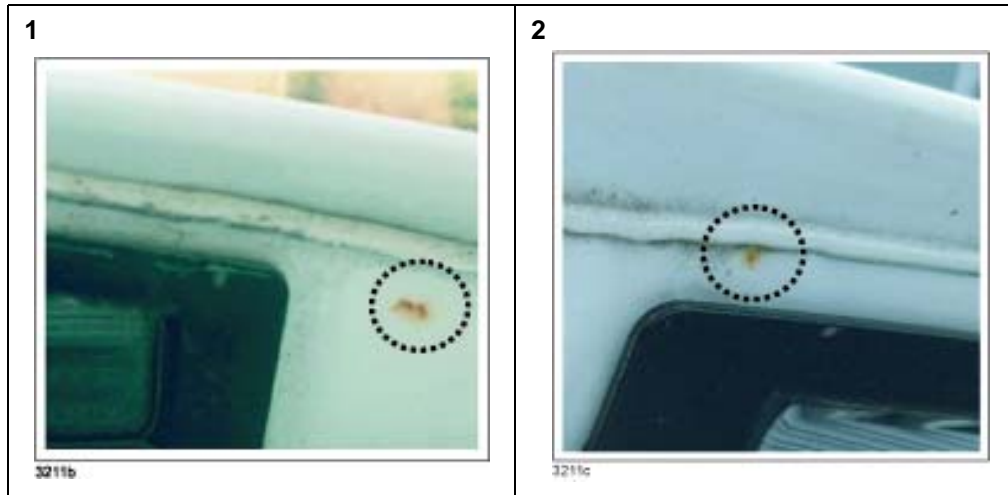
This is caused by one of the following issues:

1. The paint coating on the welding spots is not thick enough.
2. Water with iron particles is splashed up into this area around the sealant and the iron particles remain and start to rust.

To correct this problem, the following processes have been applied:

1. The welding spots are ground down prior to painting.
2. The application method of the sealant has been changed so that iron particles will not remain.
