Subject: RATTLE NOISE FROM REAR SPOILER WHEN CLOSING LIFTGATE	Bulletin No: 09-049/16
	Last Issued: 09/22/2016

2016 CX-3 vehicles with VINs lower than JM1 DK ***** 122701 (produced before November 01, 2015)

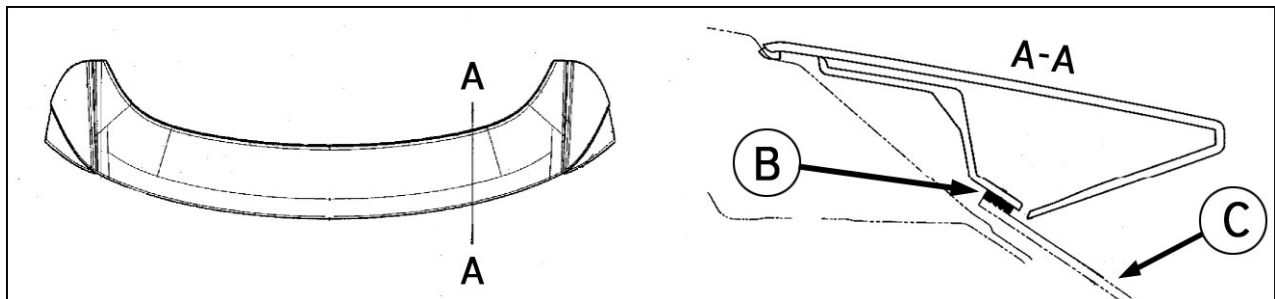
Some vehicles may exhibit a rattle noise from the rear spoiler when closing the liftgate.

This may be caused by too much clearance between the rear spoiler and liftgate glass. The excessive clearance may cause the rear spoiler to rattle when closing the liftgate.

The rear spoiler protector (B) thickness has been increased at production to improve fit between rear spoiler and liftgate glass (C) to eliminate the noise when closing the liftgate.
