2016 CX-9 Third Row Seat Head Restraint is Not Upright

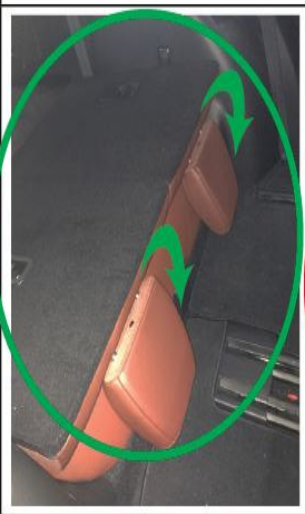
Correct head restraint fold down position.	Wrong head restraint fold down position.	Damage may occur if excessive force is applied to the back of the head restraint when in the wrong position.

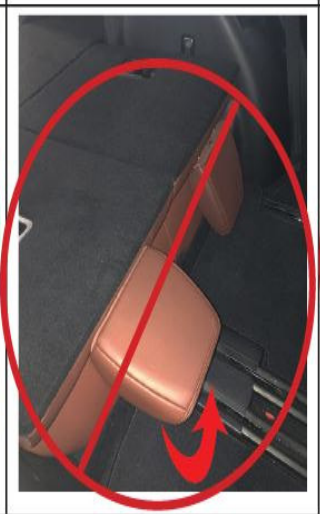
Some customers may complain about one or both third row seat head restraint(s) cannot be moved to the upright position. This may be caused by improper fold position of the head restraint(s) when the seat back is folded down.

Replace the third row seat back assembly.
