## ***Multi-Model - Rattle Noise From Rear of Vehicle (update)***

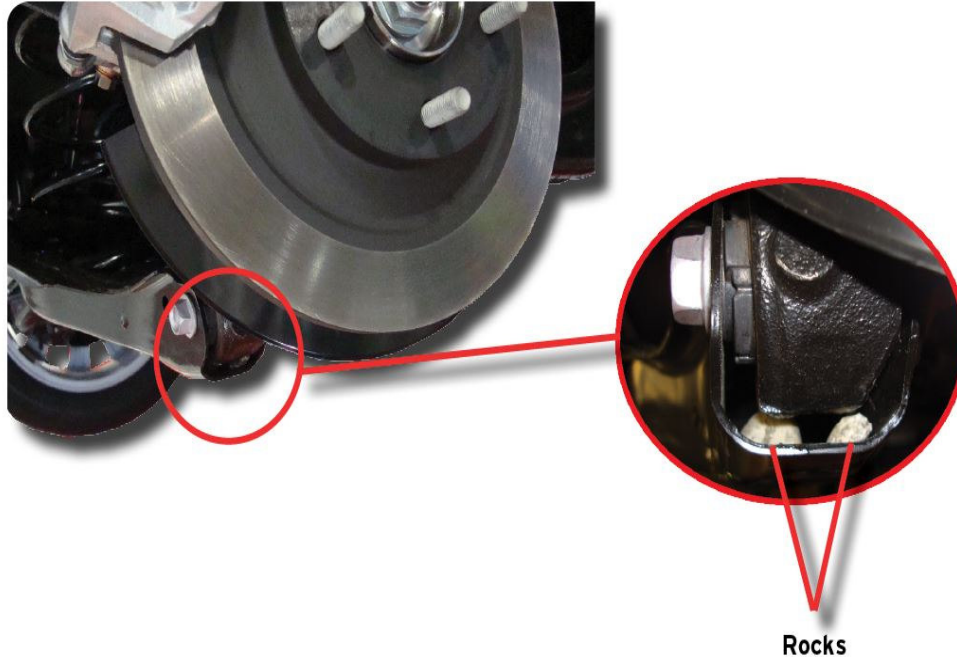
Some customers may complain about a rattle type noise coming from the rear of the vehicle. The noise is similar to a loose liftgate latch. This may be caused by rocks (road debris) in the rear lower control Arm.

Remove the rocks to resolve rattle noise concern.
