# 2016 CX-9 - Exterior Side Garnish Damage Due To Improper Vehicle Lift

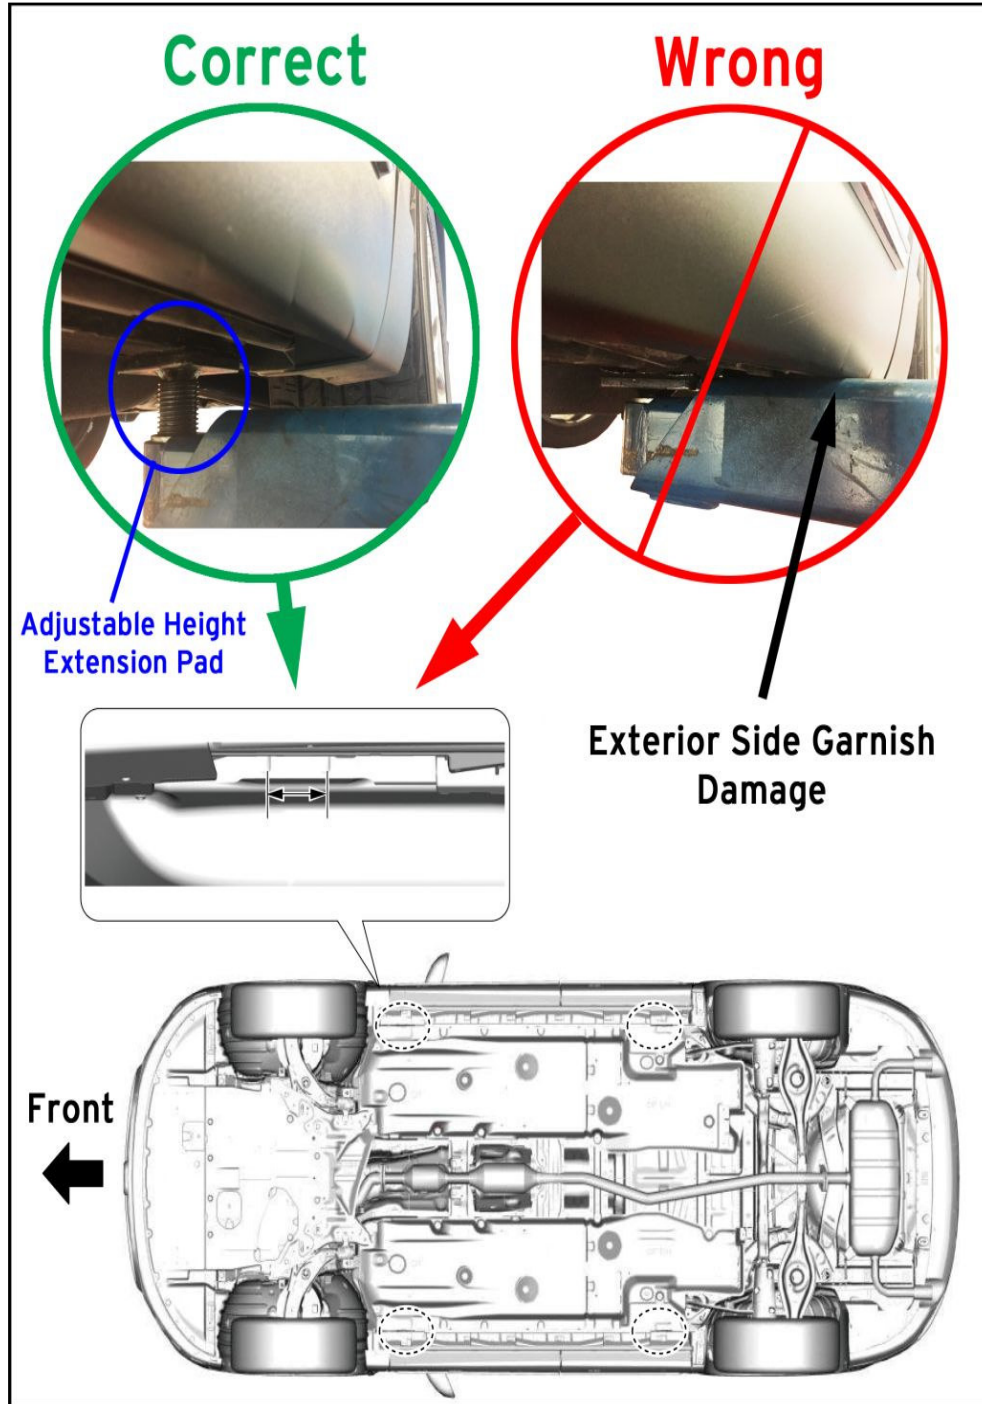
When lifting a CX-9 vehicle, adjust the height of the vehicle lift extension pad to prevent lift arm contact with the exterior side garnish. If not adjusted properly, the exterior side garnish and/or a fender may be damaged by the vehicle lift arm.
