Service Alert No: 001317

Title: 2016 CX-9 - EXTERIOR SIDE GARNISH DAMAGE DUE TO IMPROPER VEHICLE LIFT

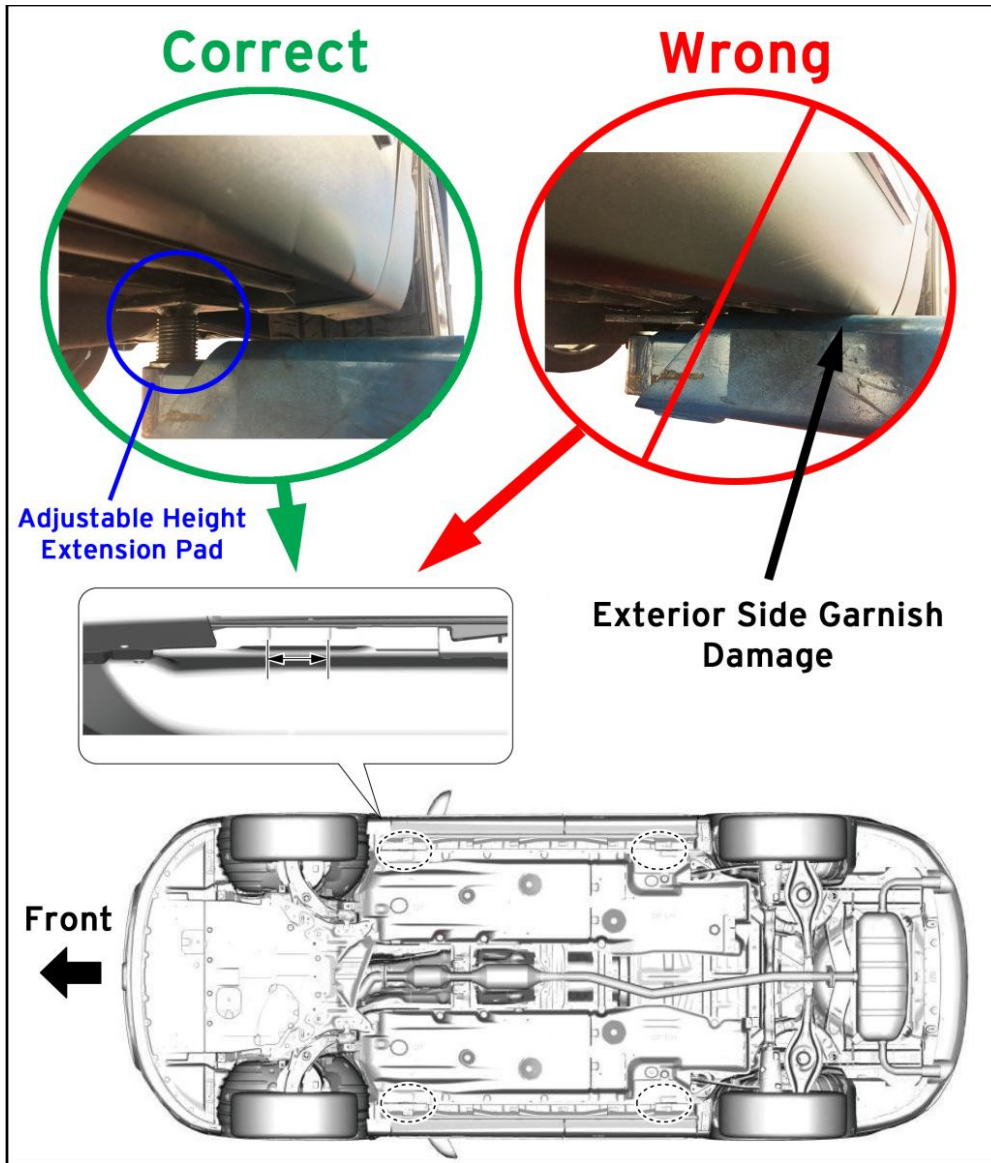
When lifting a CX-9 vehicle, adjust the height of the vehicle lift extension pad to prevent lift arm contact with the exterior side garnish. If not adjusted properly, the exterior side garnish and/or a fender may be damaged by the vehicle lift arm.
