| L624-A.07.15 | <b>To:</b> Official After Sales Network<br><b>Subject:</b> Seat update<br><b>Date:</b> 20/05/16<br><b>Pages:</b> 5 | |

Seat update

All Lamborghini Model Huracan MY 15 from VIN **FLA00163** to VIN **FLA01657**.

As a result of continuous product monitoring, Automobili Lamborghini Spa has decided to install a wiring reinforcement to prevent abrasion during seat movement.

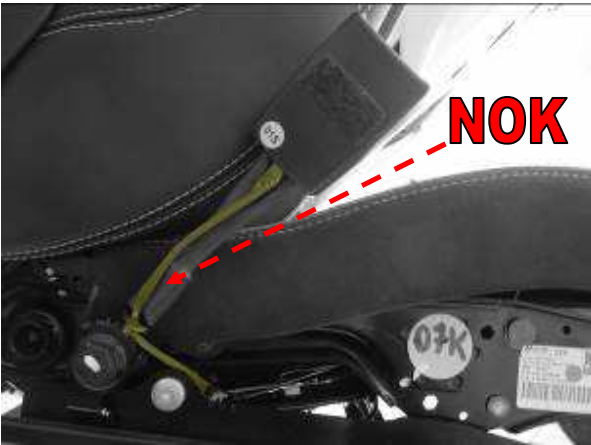
14. Change routing of the seat belt buckle wiring.  
When the buckle wire is placed onto the external side of the buckle stem facing the tunnel, it must be routed again.

Remove the clamp on the buckle and release the electrical wiring.
