SERVICE BULLETIN

Classification: EL16-003	Reference: NTB16-014	Date: February 10, 2016
-----------------------------	-------------------------	----------------------------

NISSAN; FRONT SONAR PARKING SENSOR SERVICE INFORMATION

APPLIED VEHICLES: All Nissan vehicles equipped with front sonar parking sensor

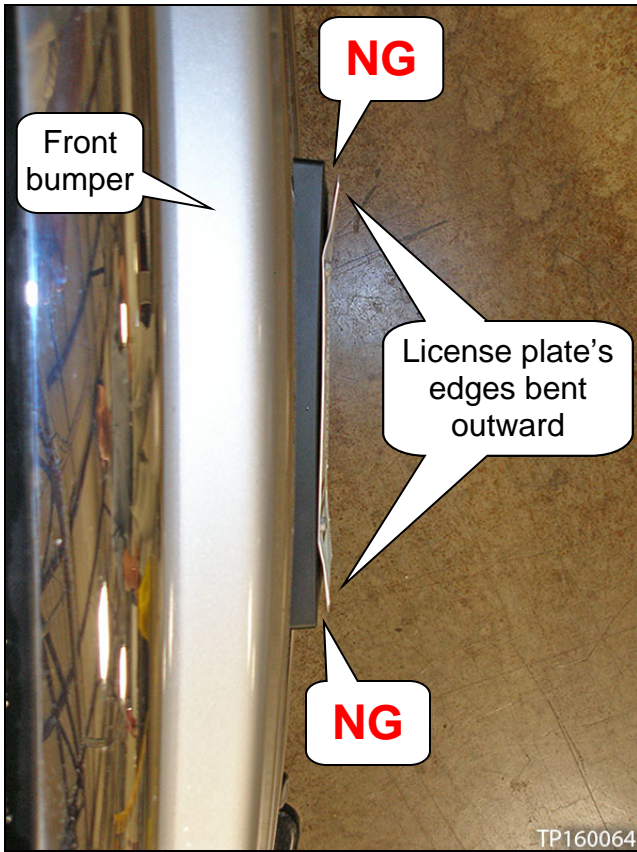
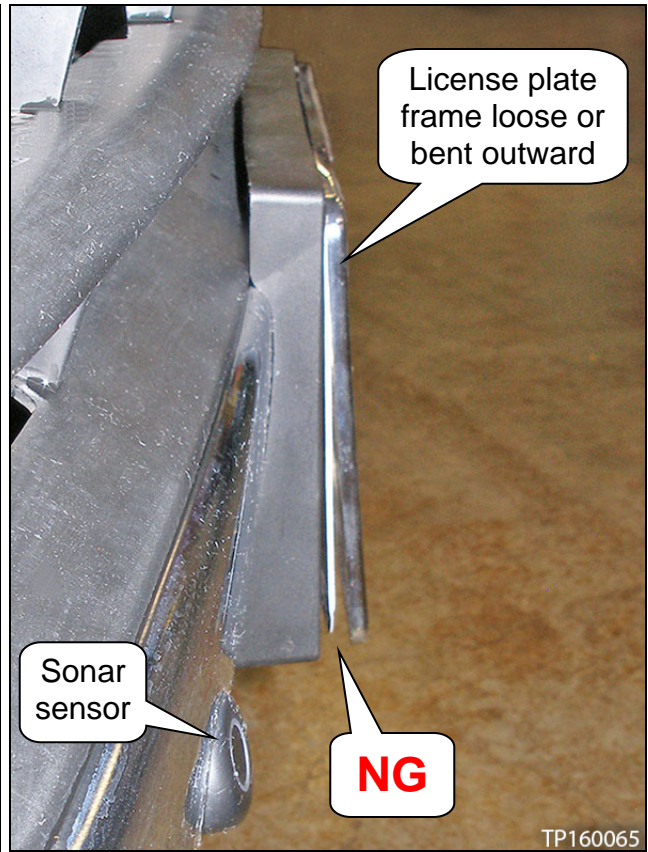
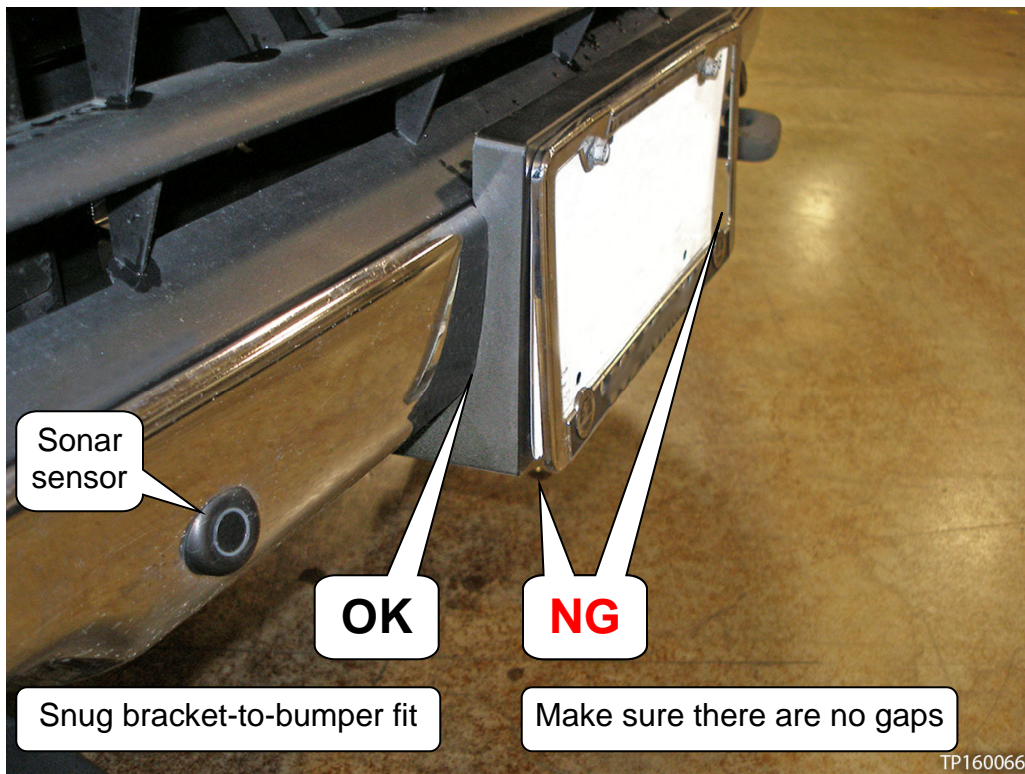
When diagnosing the front sonar parking sensor for unwanted activation (e.g. sonar activates with no obstacle ahead), inspect the front license plate, front license plate frame and if equipped, the front license plate bracket. See page 2 for example photos.

- The front license plate is bent outward from its bracket (there is a gap between the license plate and the bracket).
- or**
- The front license plate frame is bent or loose and is hanging outward, away from the license plate and/or bracket (there is a gap between the license plate frame and the license plate and/or bracket).
- or**
- The bracket is loose and is hanging outward, away from the bumper (there is a gap between the bracket and the bumper).

If any of these conditions are found, correct it by removing the gap (straighten the license plate, straighten and/or secure the license plate frame, or secure the bracket, as it applies).

- Retest the operation of the front sonar parking sensor.
