SERVICE BULLETIN

EM10-007b

TITAN, ARMADA, NV; ENGINE OIL LEAK AT RIGHT SIDE BLOCK BALL PLUG

APPLIED ENGINE: VK56DE (V8 engine)

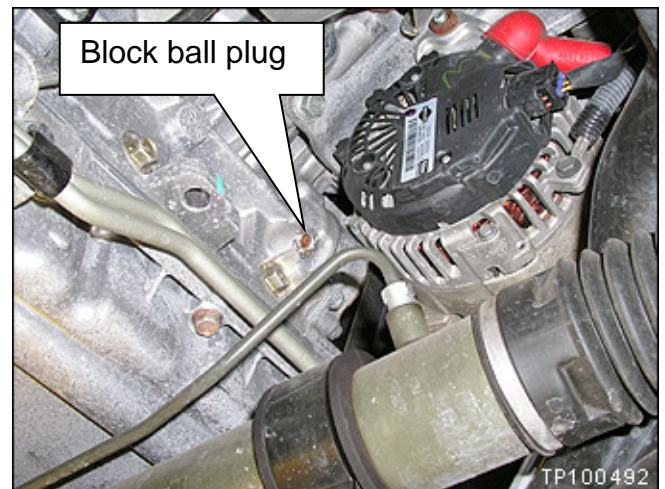
Figure 1

An oil leak at the right side block ball plug behind the alternator.

Use a punch to seat the block ball plug in the hole (refer to the Service Procedure).

NOTE: Do not replace the engine block for this incident if it should occur.
