SERVICE BULLETIN

Classification: EL03-030j	Reference: NTB03-074j	Date: February 26, 2016
------------------------------	--------------------------	----------------------------

HEADLAMP FOGGING

APPLIED VEHICLES: 2011-2016 Nissan – All models

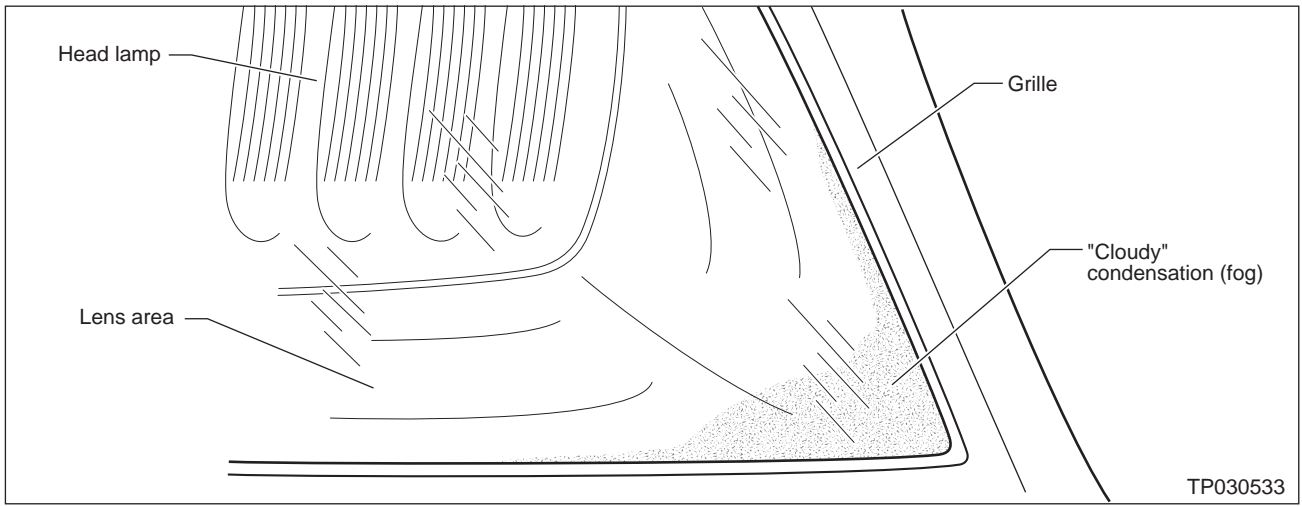
Fog may temporarily form inside the lens of the headlamp assemblies based on environmental conditions or sudden temperature changes (such as in a car wash, or parked on a cold, sunny day). This is normal. See Figure 1.

Figure 1: Example of normal condensation, ok

NOTE: This condensation can appear anywhere on the outer lens, typically at its coldest location.

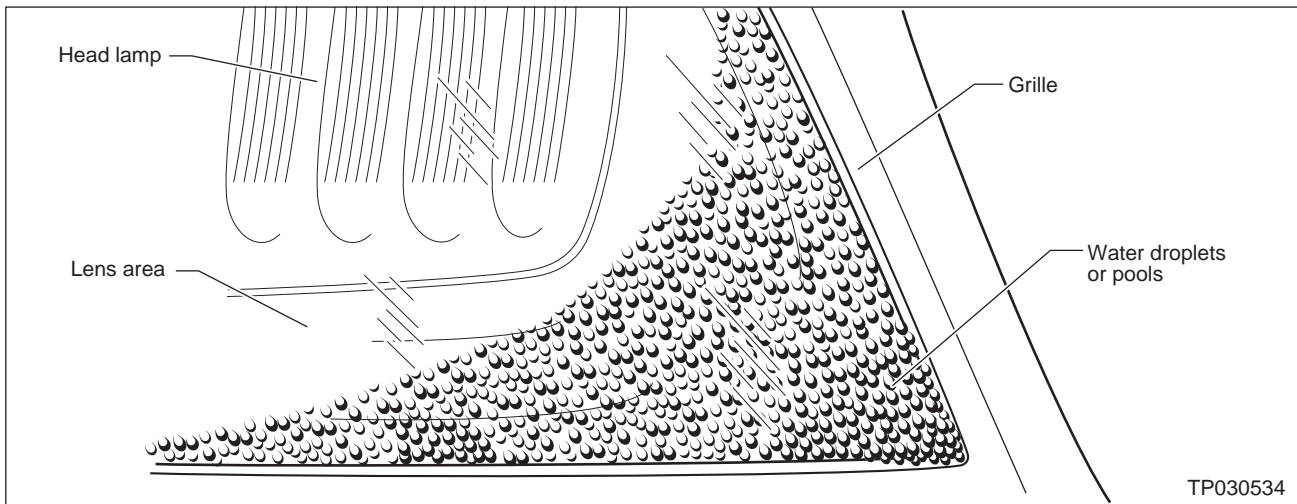
Figure 2: Condition may not be normal

If the moisture trickles, drips, or pools, it may not be considered normal and the headlamp assembly may have a water leak path. See Figure 2 for an example.

If large drops of water collect inside the lens, refer to the flow chart on page 3 to find the next step.
